Item No. 11 Town of Atherton

CITY COUNCIL STAFF REPORT – REGULAR AGENDA

SUBJECT: REVIEW OF RECOMMENDATIONS REGARDING MEDIAN STREET TREES ON TUSCALOOSA AND MT. VERNON; PROVIDE FEEDBACK AND DIRECTION TO STAFF REGARDING THEIR DISPOSITION

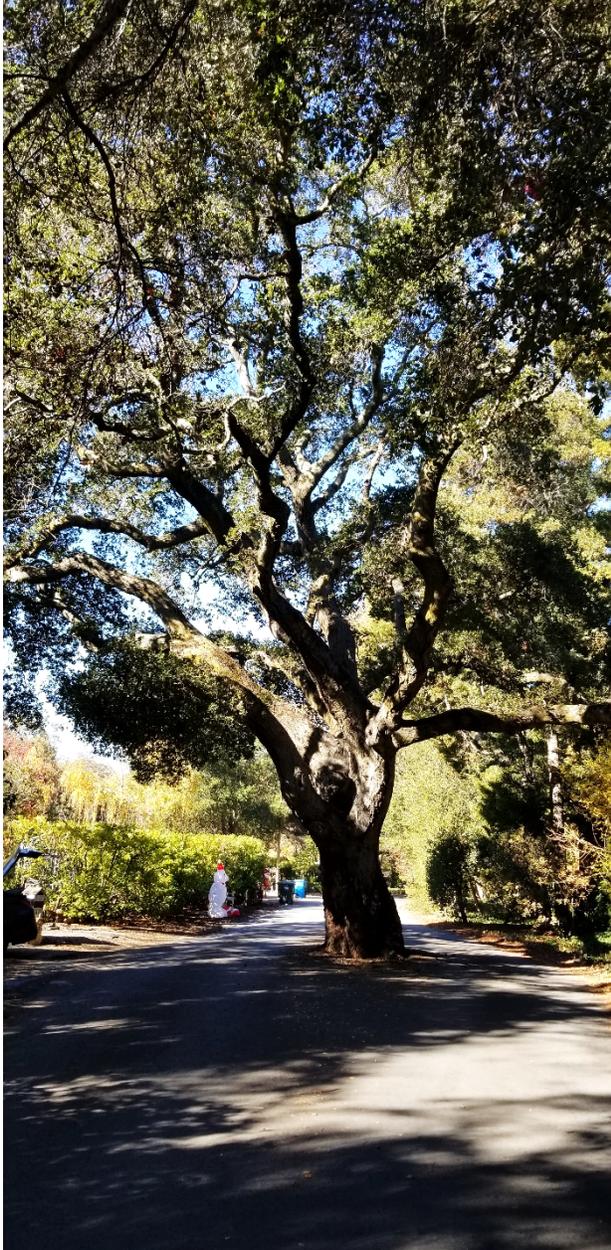
Figure 2: Looking west at subject tree.

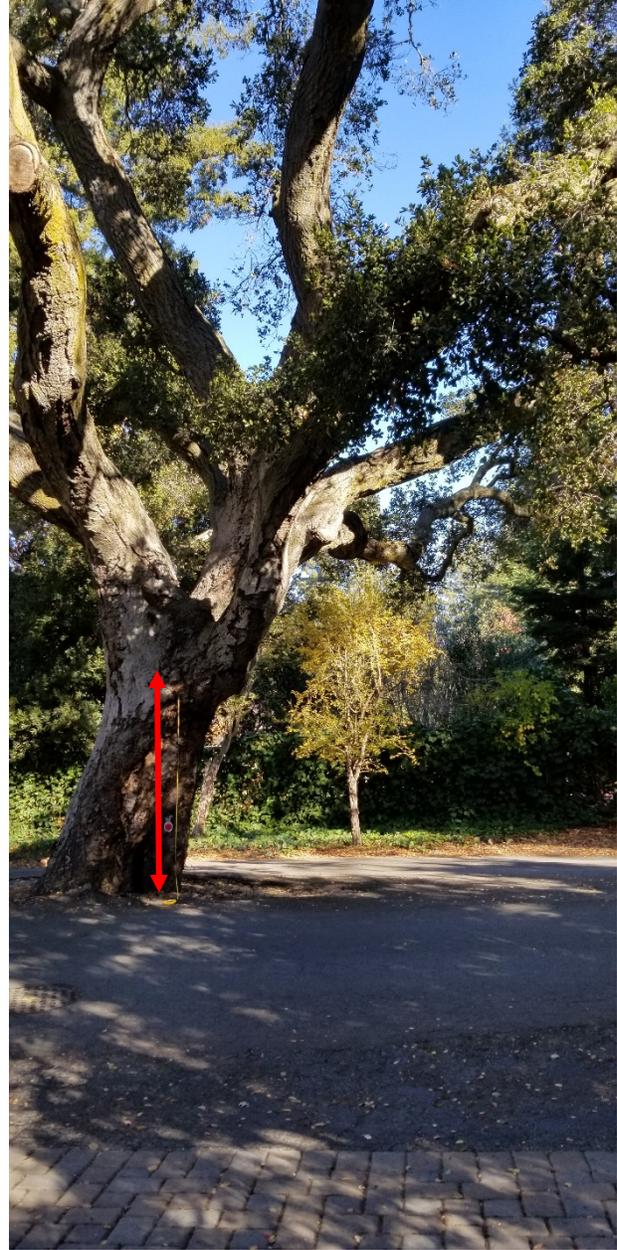
- Canopy heavy to the south east.
- Decay visible on southern trunk extending from grade level 7-feet up to first lateral branch. Cavity at base of defect probed to 1-foot depth.
- Sounding of eastern root crown/lower trunk suggests minimal shell wall present.
- Visible decay at northern root crown with delignified decayed wood present (white rot).
- Small 3-inch cavity at western root crown.
- Recent large stress fractures present in canopy.

Figure 3: Looking north, red arrows indicate height of visible decay column.

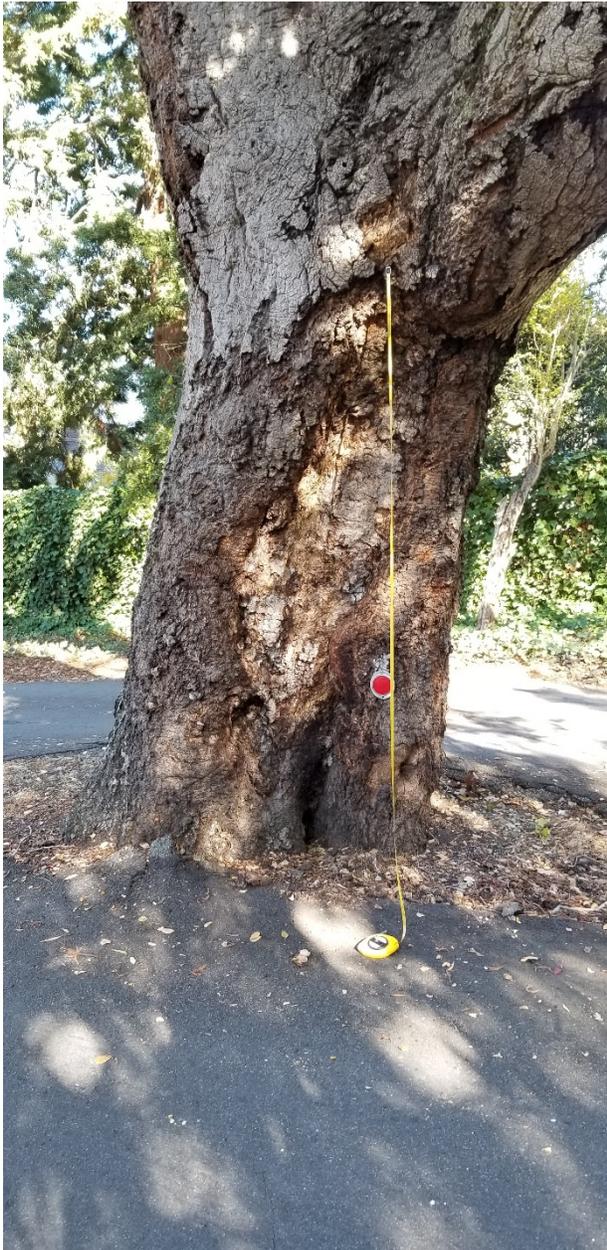
Figure 4: A closer look at the visible decay area on the south area of trunk. Red arrow indicates cavity probed to a depth of 1-foot.

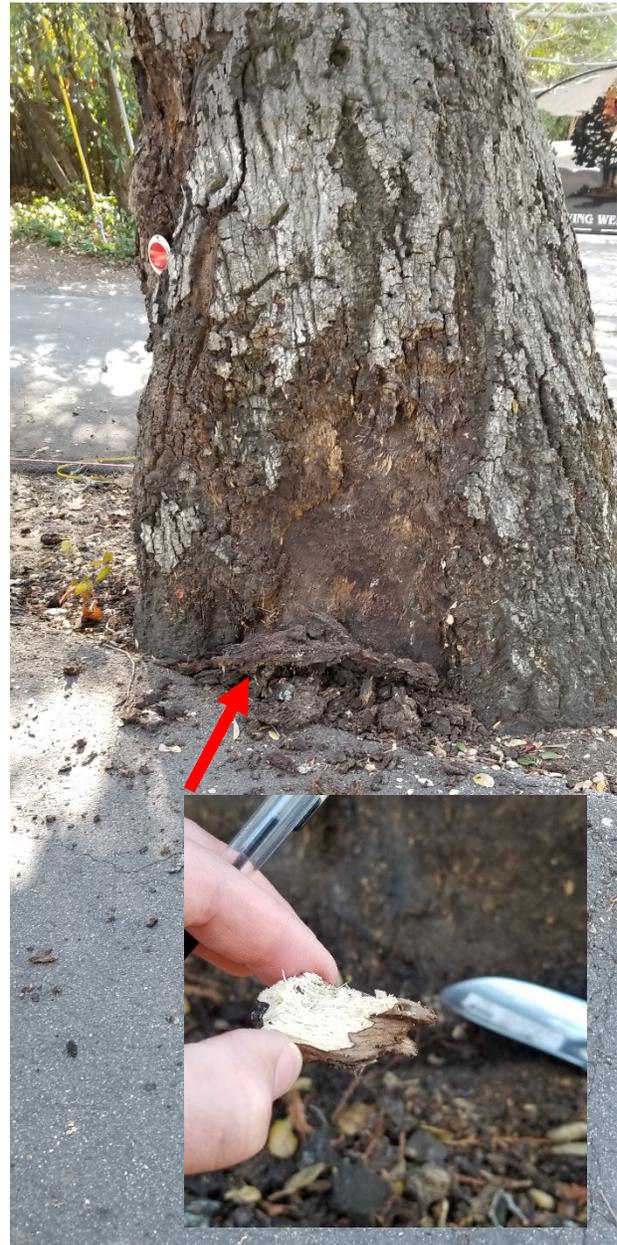
Figure 5: Looking at the northern root crown, bark fell off easily while sounding with a rubber mallet and dead wood was present below. Minor excavation of the northern root crown revealed soft delignified wood (white rot).

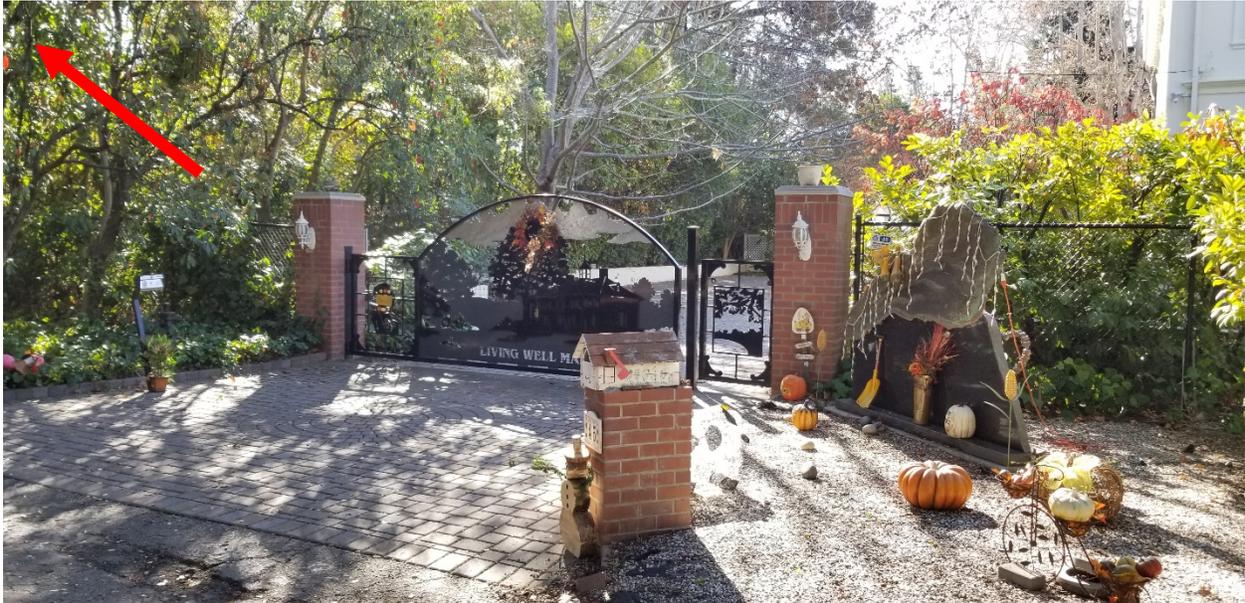
Static targets in the area include the gate area of 45 Mt. Vernon Ln. and the utility pole east of there. The static targets have a ***High*** likelihood of impact due to being in the predicted direction of failure (underside of lean). Targets are impractical to move. Moving targets such as cars and pedestrians were determined to have a ***Low*** likelihood of impact, as the target area has no thru traffic on the road and cars seldomly park on the road.

Figure 6: Looking southeast at entrance gate of 45 Mt Vernon Lane, red arrow shows where utility pole is located out of frame.

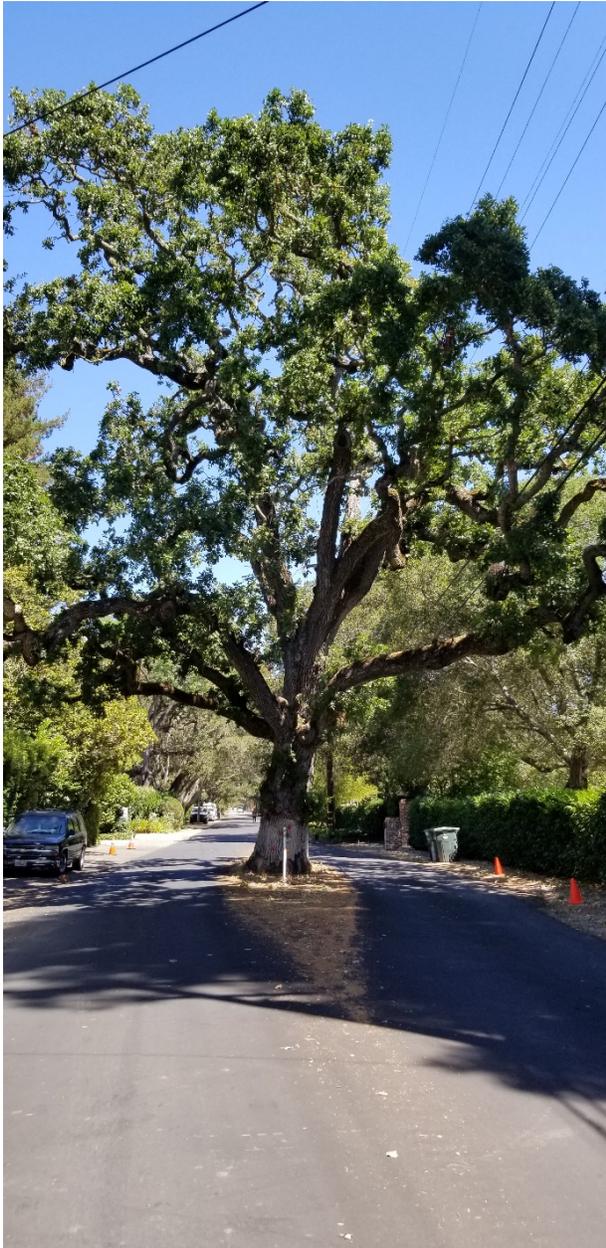
Figure 2: Looking north at subject tree, note utility lines on east side of canopy.

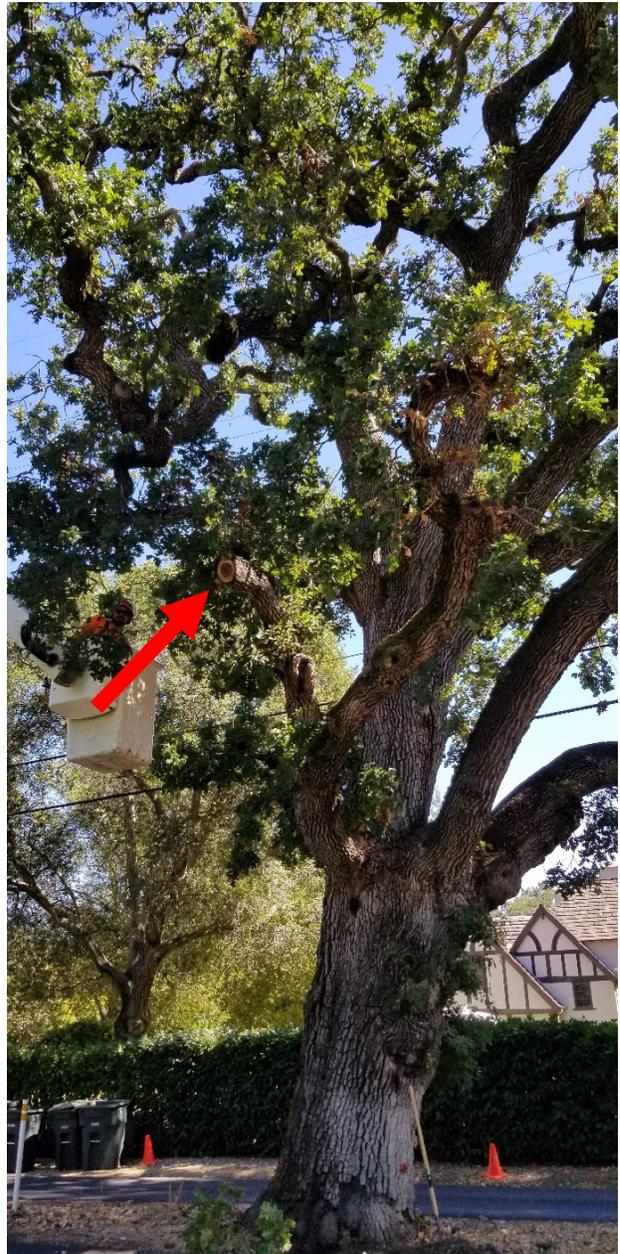
Figure 3: Looking east, WCA trimmer navigates the canopy in an arial lift, large branch removed indicated by red arrow had significant internal decay.

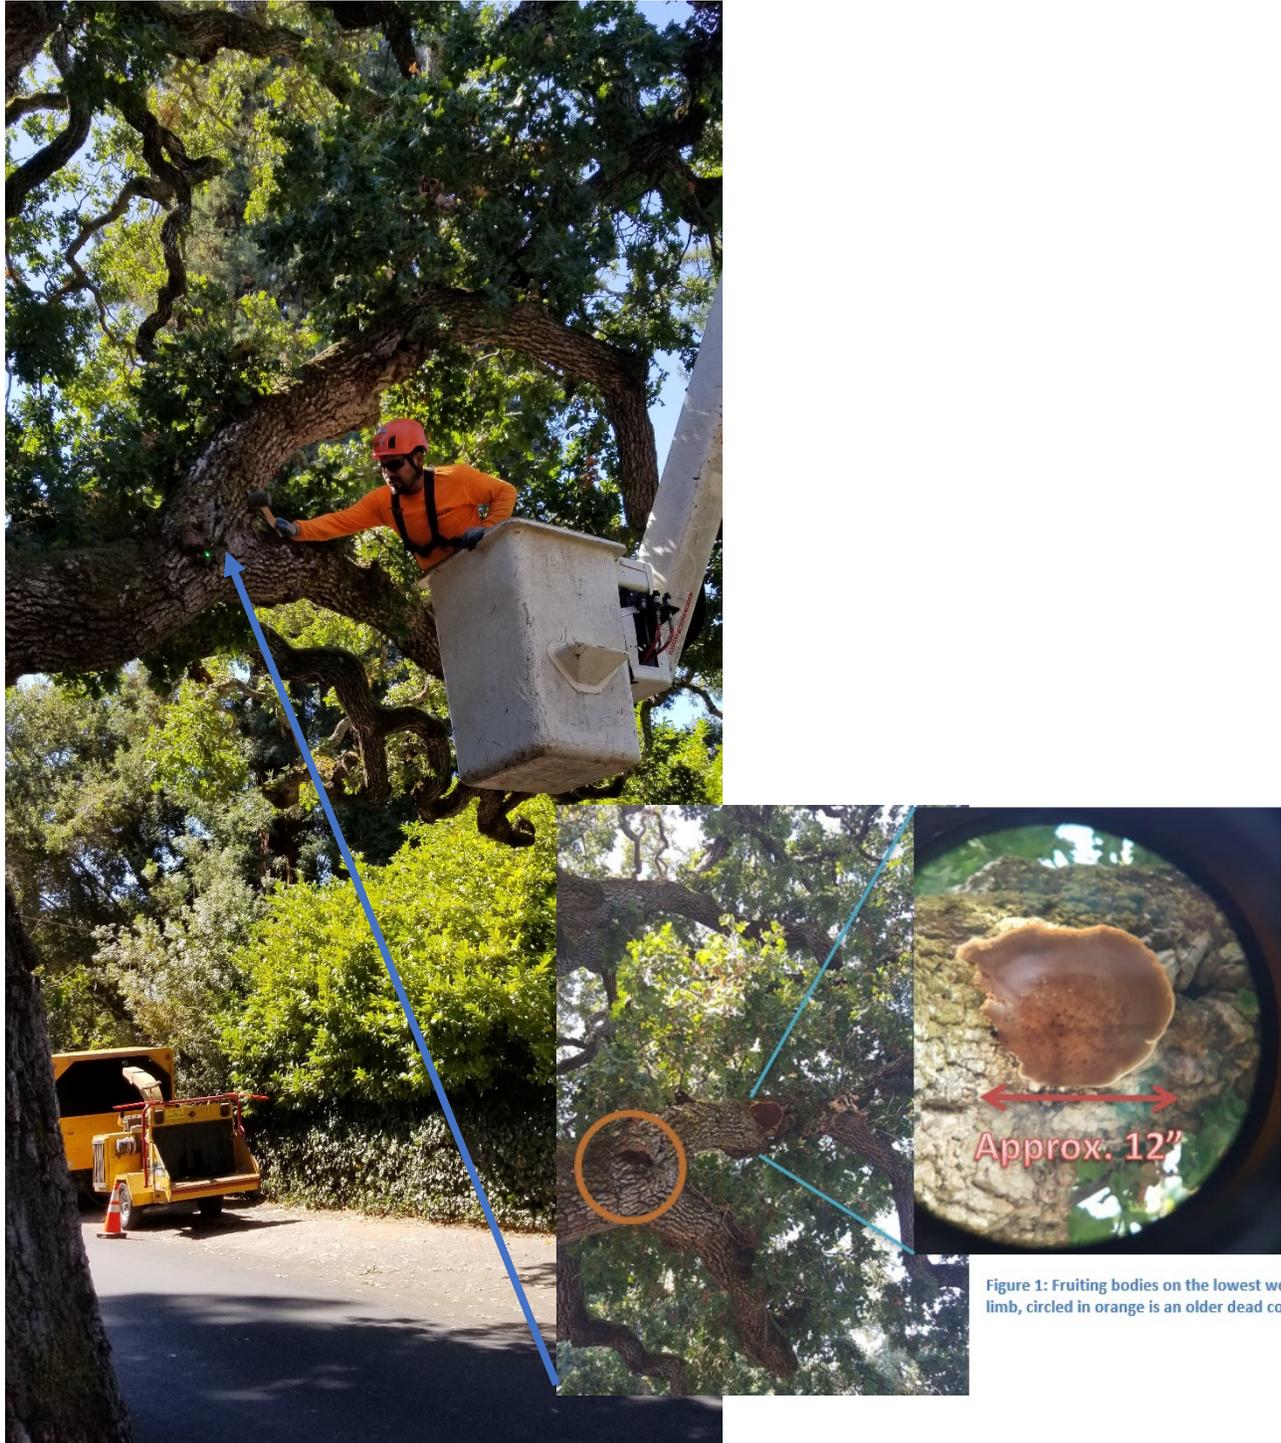
Figure 4: Left photo shows trimmer inspecting location, where 2017 inspection (photo right) had noted a large fruiting body. The location was sounded with a mallet and a resonating deep note assured internal decay was present.

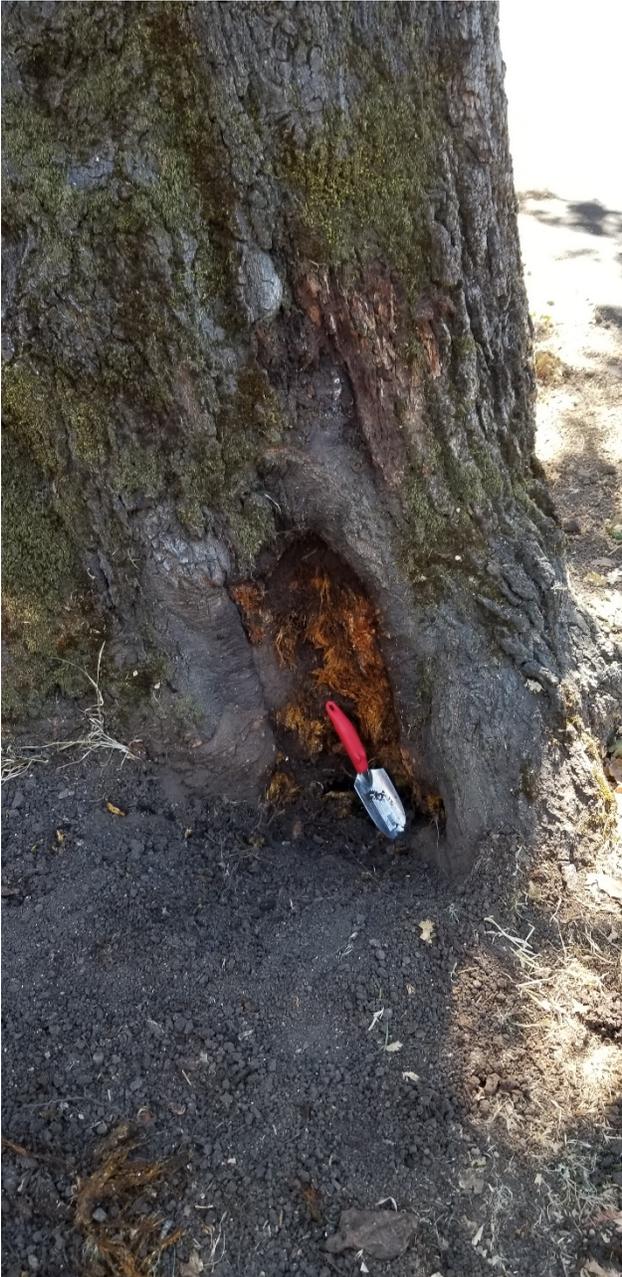
I found a decay pocket while inspecting the northern root crown. When I excavated the area revealed decaying wood that resembled a type of white rot, with very wet soft wood. I was able to reveal a decayed area 2-feet tall and 1-foot deep and was able to probe 6 to 8-inches into the tree, at the bottom of the decayed area. Callusing around the cavity was present, however decay appeared to be advancing past **CODIT** walls 2 and 4. The east and west sides of the trunk had irregular texture that appears to be callousing from buttress roots removed along time ago. During root crown excavation on the west and southeast side of the tree, I was unable to locate buttress roots within the top 12 inches of the tree directly adjacent to the trunk. The concrete perimeter of the planter area measured up to 8-inches thick on the west side of the trunk and heavy base rock was present in the area.

Figure 5: Decay pocket excavated on north side of trunk. The decay visible here is suspected to have a connecting column to the decay located directly above in the western canopy.

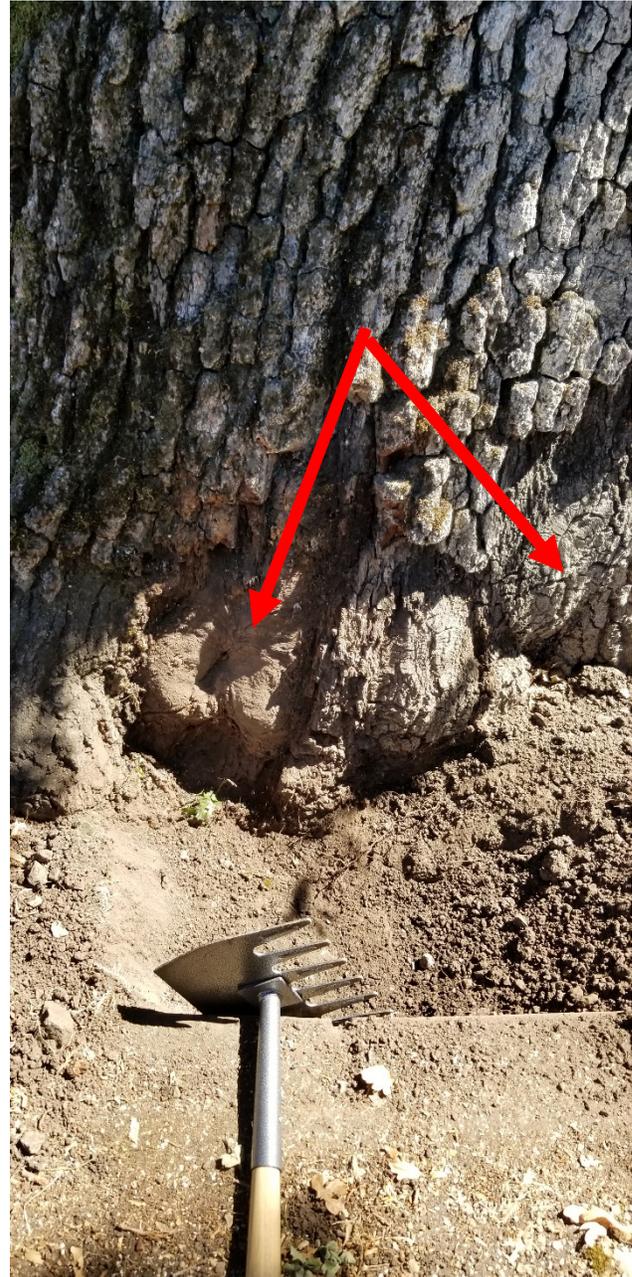
Figure 6: Attempted root crown excavation on western side near concrete curb. The callused wounds on the trunk indicate that buttress roots may have been removed in this area long ago. The concrete curb was measured to a depth of 8-inches but compacted gravel limited efforts to dig further.

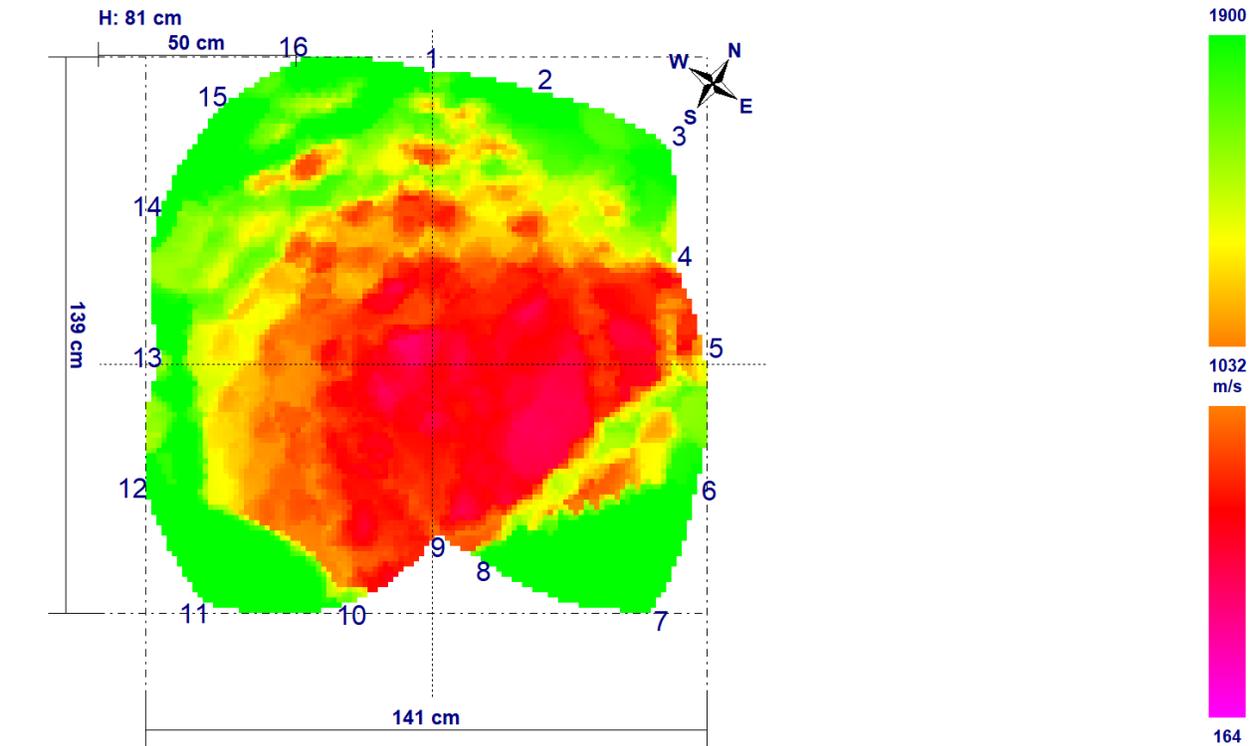
The above tomogram shows a large amount of structurally compromised wood (red areas). Sound waves traveled faster (meters per second) through structurally sound areas of the trunk and are represented by the green coloring. The wood on the northwest side of the tree, where the bark is missing, looks to be mostly structurally sound, with the red splotches most likely indicating incipient decay. The cavity located behind sensor #9 seems to be bolstered by response growth indicated by the green areas behind sensors #7 and #11.

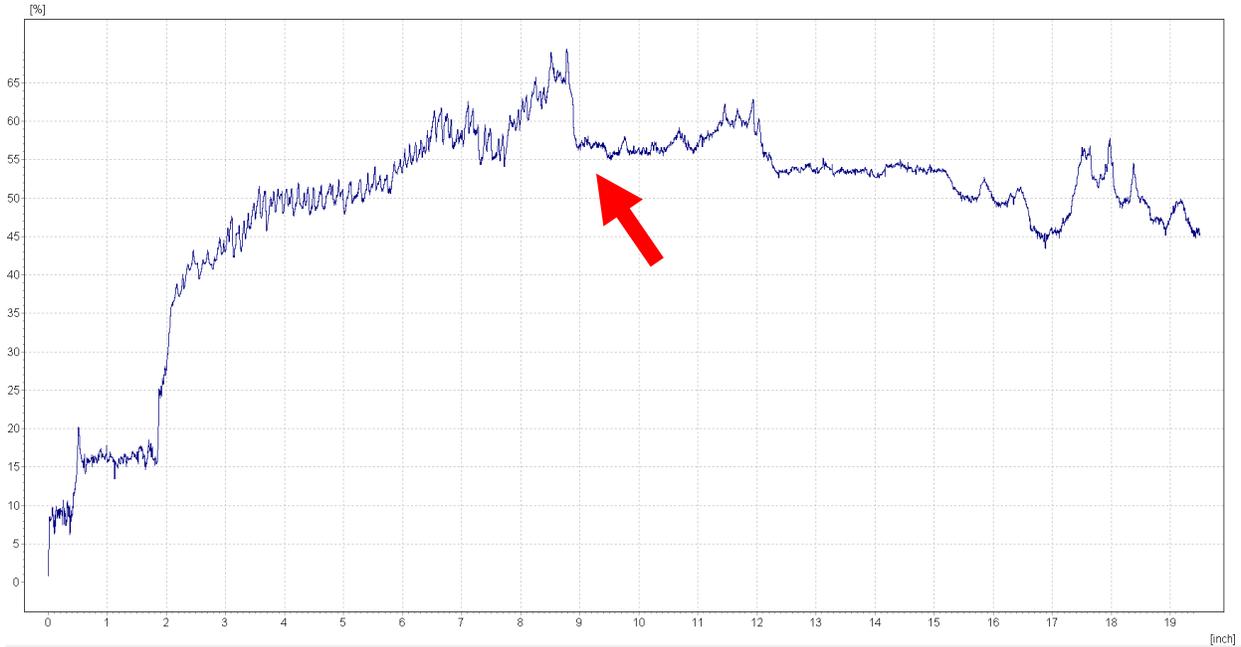
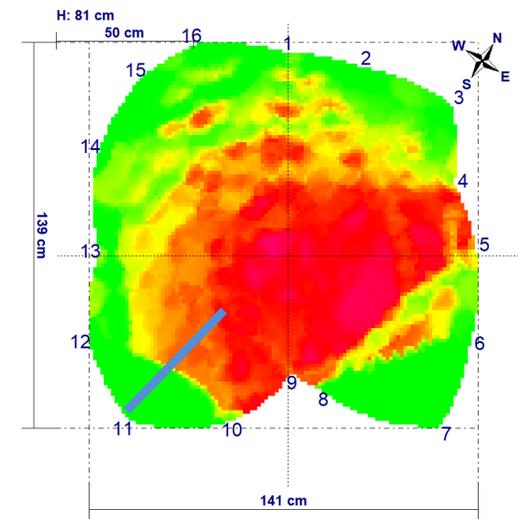
Resistograph® Reading Behind Sensor #11

The above Resistograph® reading was taken from sensor #11 towards sensor #2 (see **blue line** in tomogram to the left). The reading correlates with the tomogram in that wood quality begins to degenerate at about 9 inches into the trunk (**red arrow above**). Resistance is lower when compared to solid wood and the peaks are less defined and more linear. The first inch or two of tissue is bark tissue which does not show the same resistance as wood tissue.

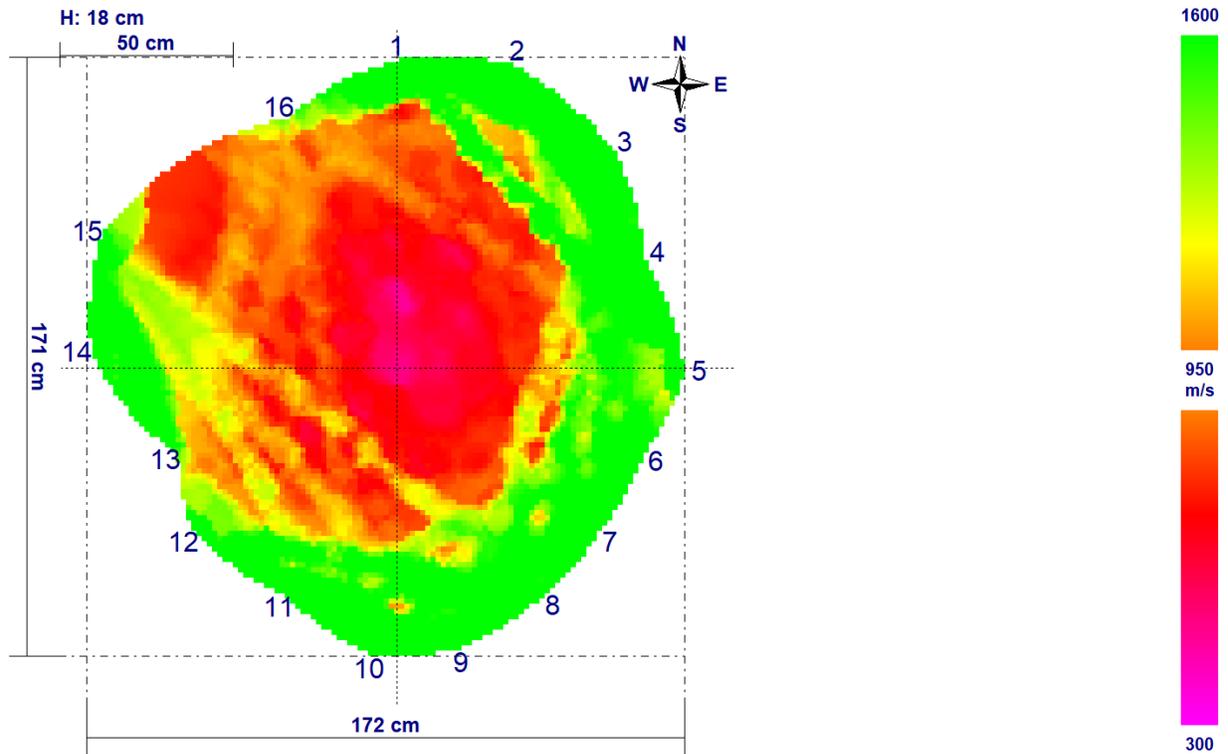
The above tomogram also shows a large amount of structurally compromised wood (red areas). Sound waves traveled faster (meters per second) through structurally sound areas of the trunk and are represented by the green coloring. The dysfunctional wood reaches the surface between sensors #15 and #16 (location of cavity), but the remainder of the trunk has solid wood around the perimeter.

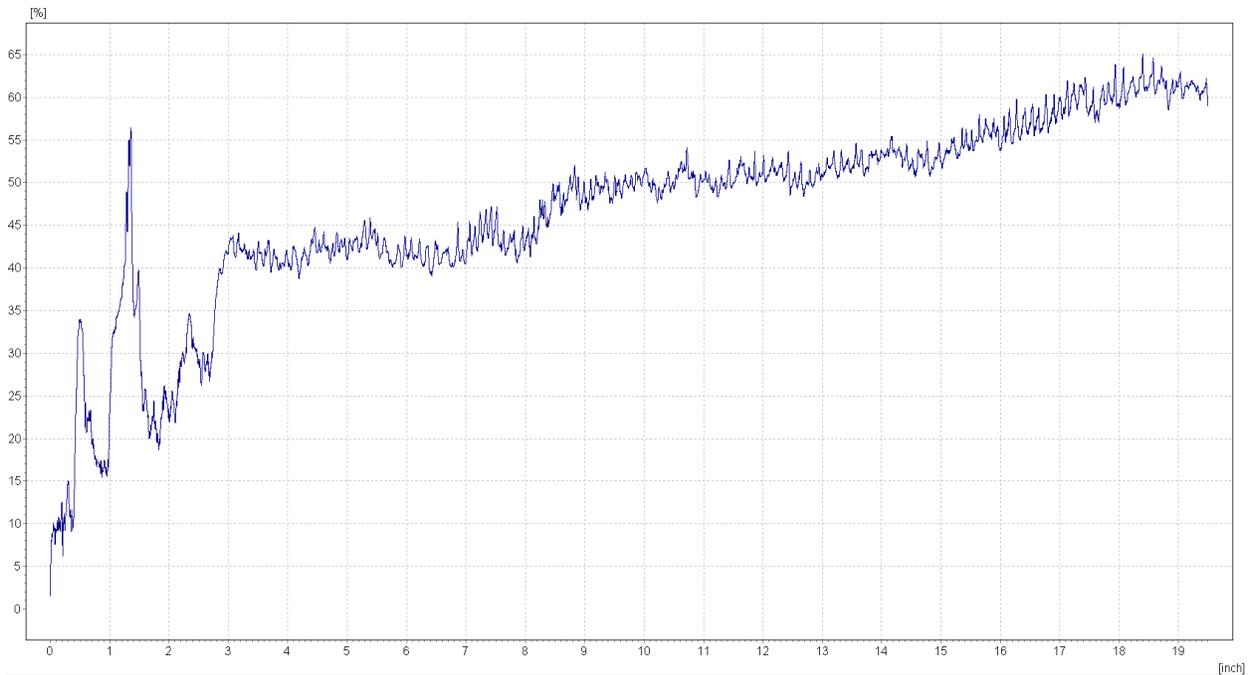
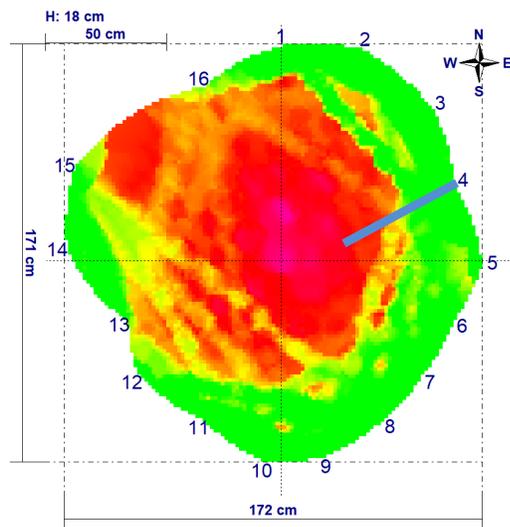
Resistograph® Reading Behind Sensor #4

The above Resistograph® reading was taken from sensor #4 towards sensor #13 (see **blue line** in tomogram to the left). The reading does not indicate any obvious changes in wood quality going from the red area to the green area. It may be that the red area has incipient decay that is still too subtle to register significantly via resistance drilling.

Valley oak wood is very dense and heavy, which also may explain why the wood in the red area is still showing a good amount of resistance even though sound did not travel through it as fast as the unimpacted wood in the green areas. The first inch or two of tissue is bark tissue which does not show the same resistance as wood tissue.

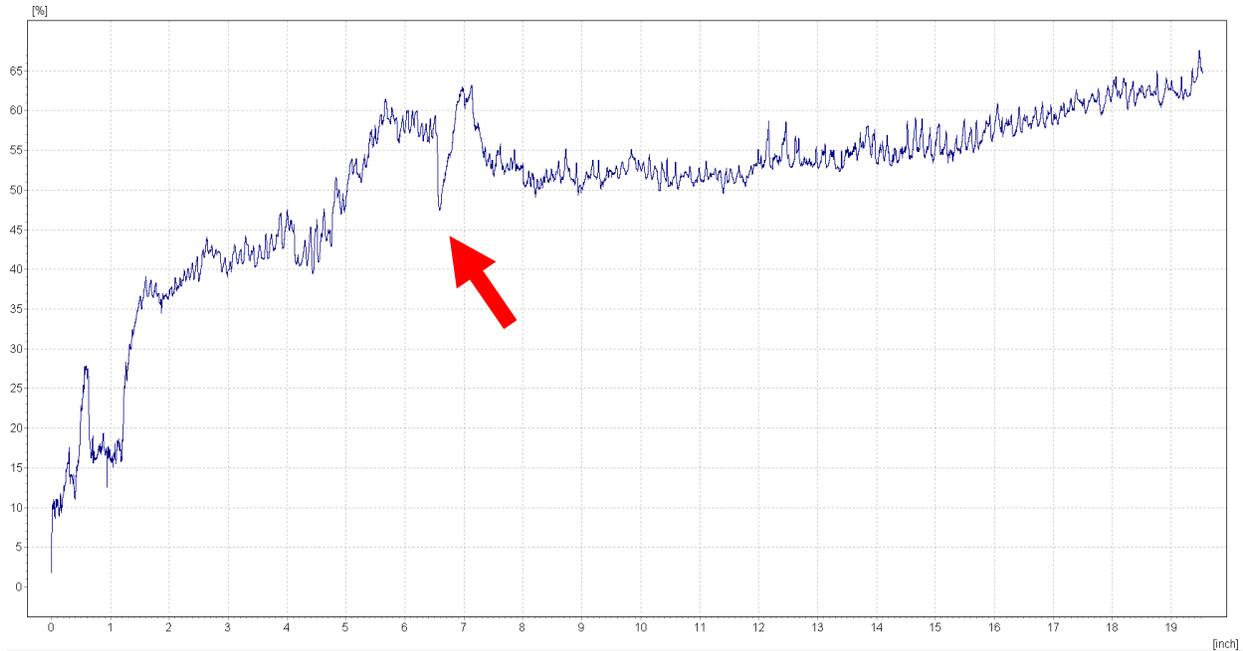
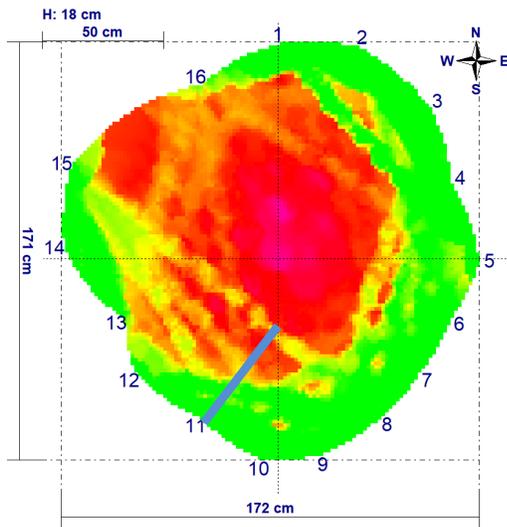
Resistograph® Reading Behind Sensor #11

The above Resistograph® reading was taken from sensor #11 towards sensor #2 (see [blue line](#) in tomogram to the left). The reading correlates with the tomogram in that wood quality changes at around 6.5 inches into the trunk. The peak in resistance at 7 inches may indicate that the decay has been **compartmentalized**.

Valley oak wood is very dense and heavy, which may explain why the wood in the red area is still showing a good amount of resistance even though sound did not travel through it as fast as the unimpacted wood in the green areas. The first inch or two of tissue is bark tissue which does not show the same resistance as wood tissue.

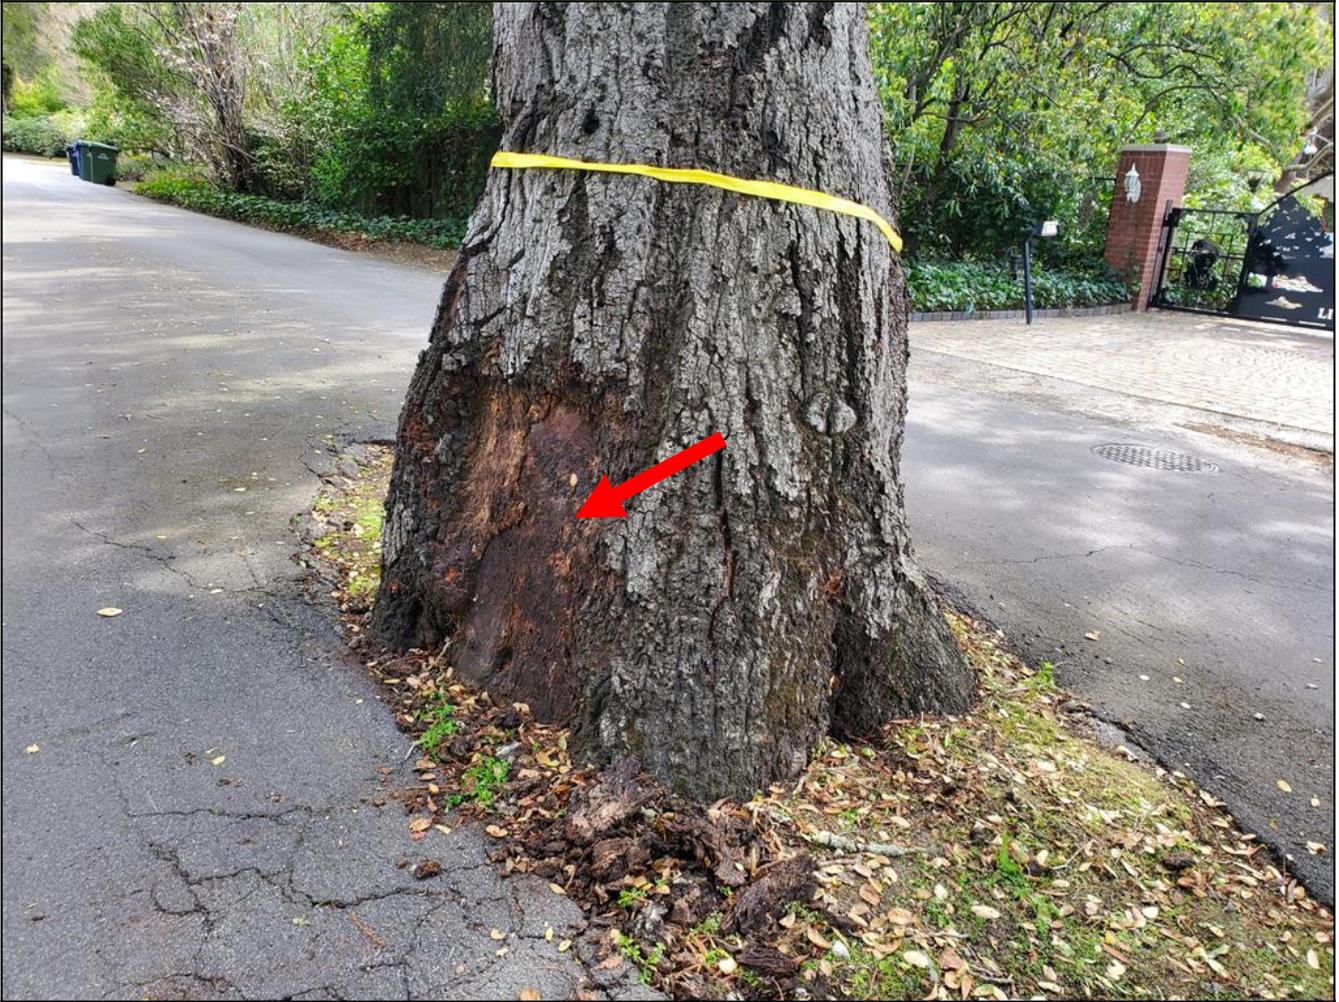
The foliage of the tree is in fair health judging by its color and density for the given species. The base of the tree is missing bark tissue on its north side (see Photo #1 in Appendix A). There is also a **cavity** on the south side of the trunk which looks to be surrounded by **woundwood** or **response growth** (see Photo #2 in Appendix A).

Coast Live Oak (looking southwest)
The base of the tree is missing bark tissue on its north side (**red arrow**).

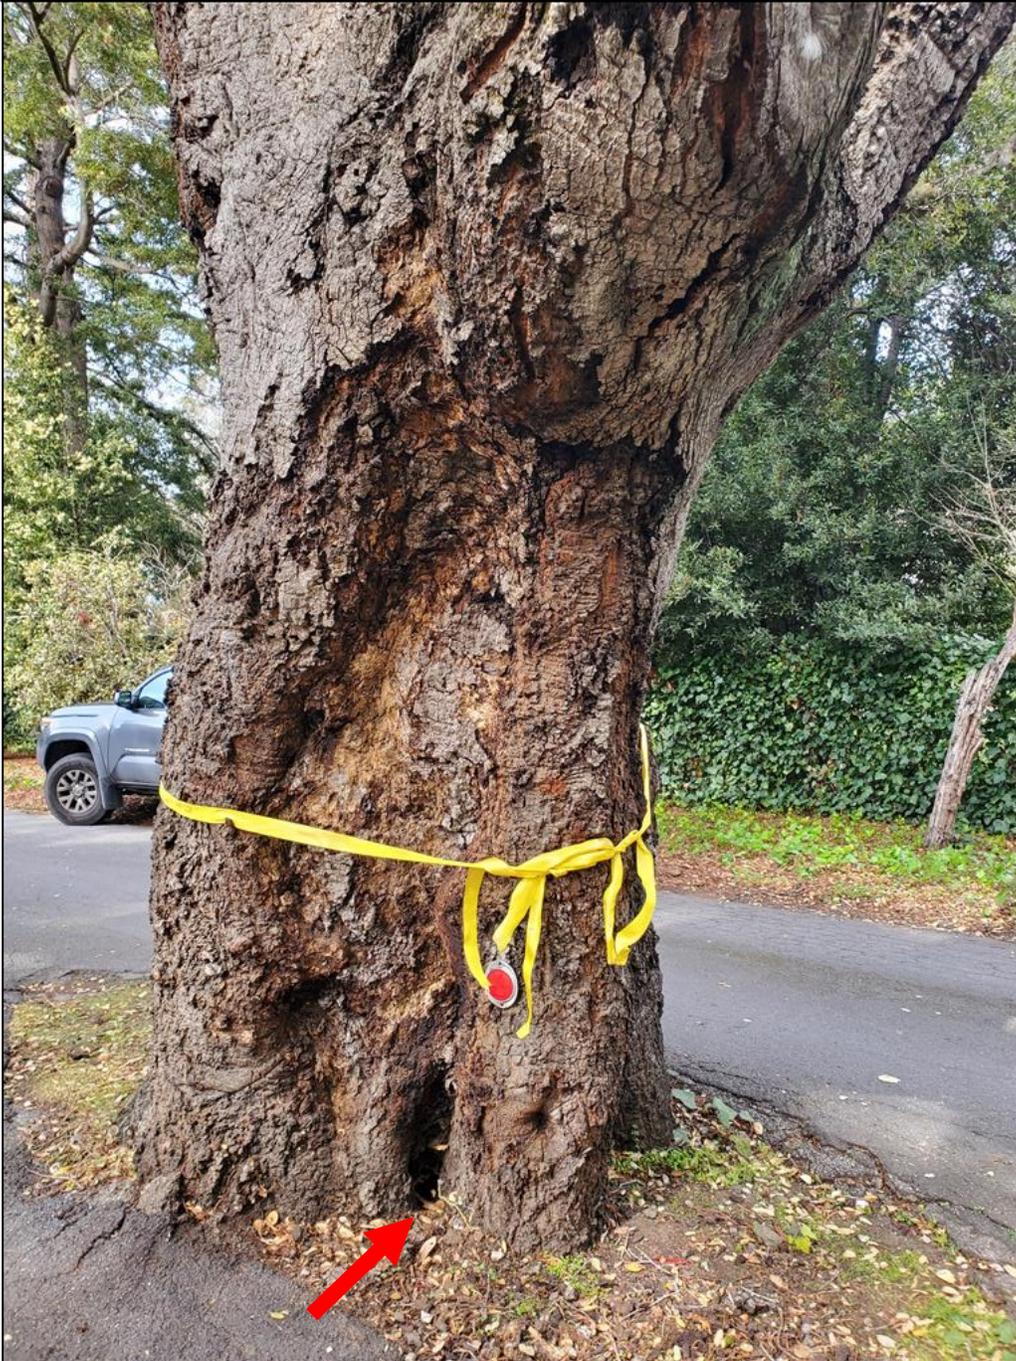
Photo #2

There is a cavity (**red arrow**) on the south side of the trunk which looks to be surrounded by woundwood or response growth.

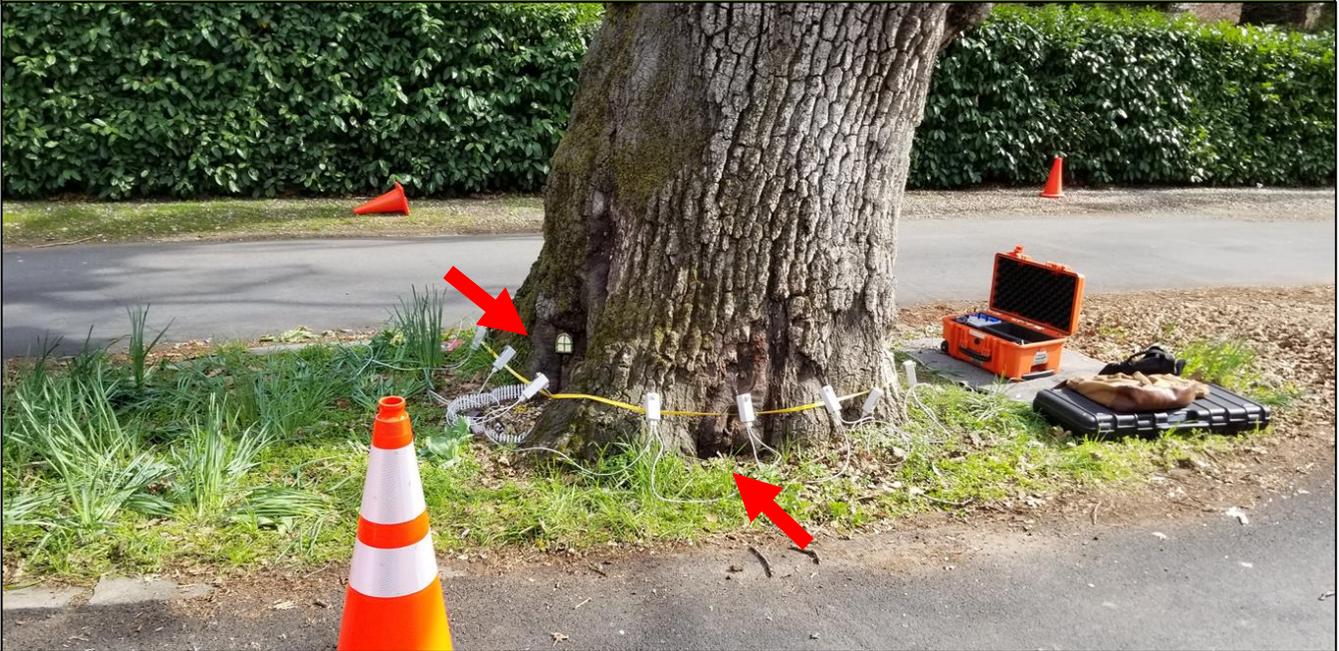
At the time of inspection, this deciduous oak was without leaves (right photo). I observed a couple small, ground-level cavities on the west and south sides of the trunk (see Photo #3 in Appendix A).

I observed a couple small, ground-level cavities (**red arrows**) on the west and south sides of the trunk.
