## Item No. 16 Town of Atherton

### **CITY COUNCIL STAFF REPORT – PUBLIC HEARING**

**SUBJECT:** APPEAL OF THE DECISION OF THE PLANNING COMMISSION  
TO DENY A HERITAGE TREE REMOVAL PERMIT AT 222  
CAMINO AL LAGO

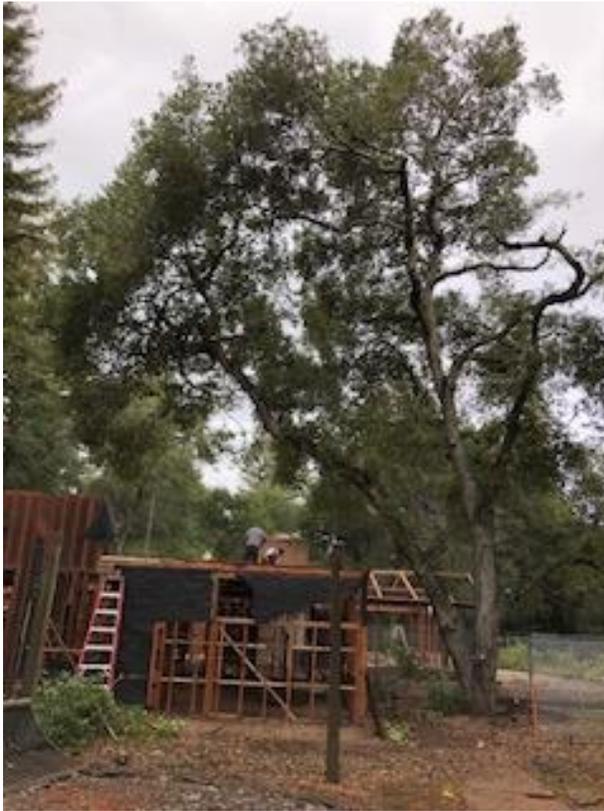
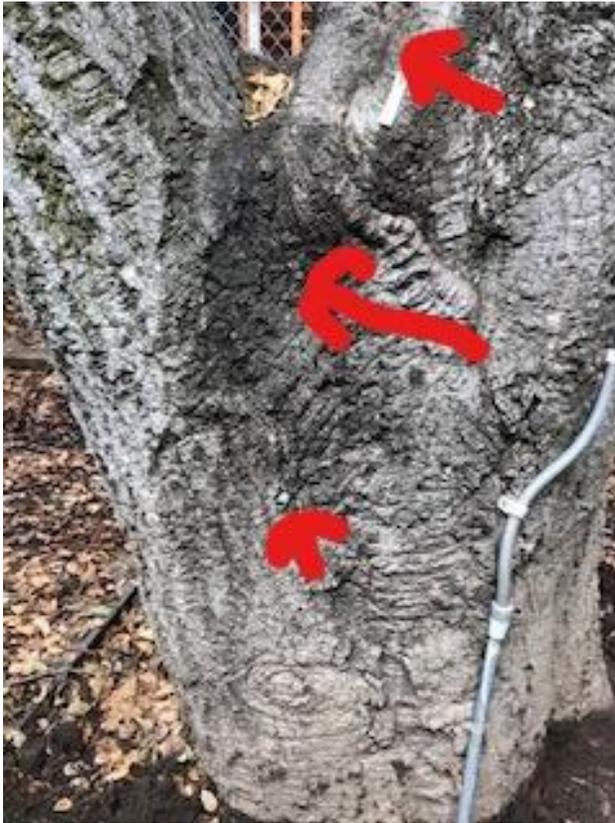
The tree in question is a coast live oak (*Quercus agrifolia*) with a diameter at breast height of 38.2 inches. The tree is located on the front setback for the new planned home. The estimated height of the oak is 50 feet with a total crown spread of 60 feet. The vigor of the oak is poor-fair with slightly less than normal shoot growth for the species. The form of the oak is poor with codominant leaders at 4 feet and poor attachment of those leaders.

The poor attachment is due to included bark at the crotch formation and decay at several locations around and below the crotch. A drain tube was installed years ago to help drain rain water from the poor crotch formation. A cable was placed between the leaders to help support the poor crotch and a second cable was installed recently.

The large oak receives a condition rating of 45 on a 1-100 scale (poor). Attempts to improve the trees form have had limited results. The drain at the base of the crotch is an obvious indicator of decay in the trunk. The drill test confirmed the presence of decay. The cabling of the tree is the result of an arborist concerned about the possible failure of the large leader over the house. A second cable 30 or more years later confirmed the original arborist's doubts.

**Poor crotch formation with area of decay (top arrow), included bark (center arrow) and installed drain tube (lower arrow).**

Trimming the oak with ANSI standards and Best Management Practices will not improve the poor form of the tree or greatly lessen the trees chances of failure. Remove and replace this oak as removal is the only method that will eliminate all hazard and liabilities associated with the tree. The oak should be replaced with a coast live or valley oak of a size acceptable to the town arborist or planning commission.

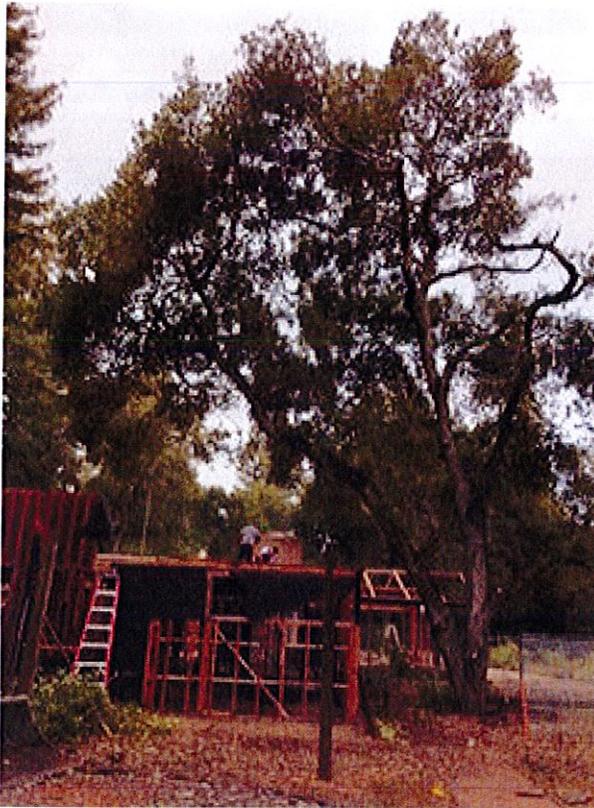
The tree in question is a coast live oak (*Quercus agrifolia*) with a diameter at breast height of 38.2 inches. The tree is located on the front setback for the new planned home. The estimated height of the oak is 50 feet with a total crown spread of 60 feet. The vigor of the oak is poor-fair with slightly less than normal shoot growth for the species. The form of the oak is poor with codominant leaders at 4 feet and poor attachment of those leaders.

The poor attachment is due to included bark at the crotch formation and decay at several locations around and below the crotch. A drain tube was installed years ago to help drain rain water from the poor or split crotch formation. A cable was placed between the leaders to help support the poor crotch and a second cable was installed recently evidence of the arborists concern as to the safety of the tree.

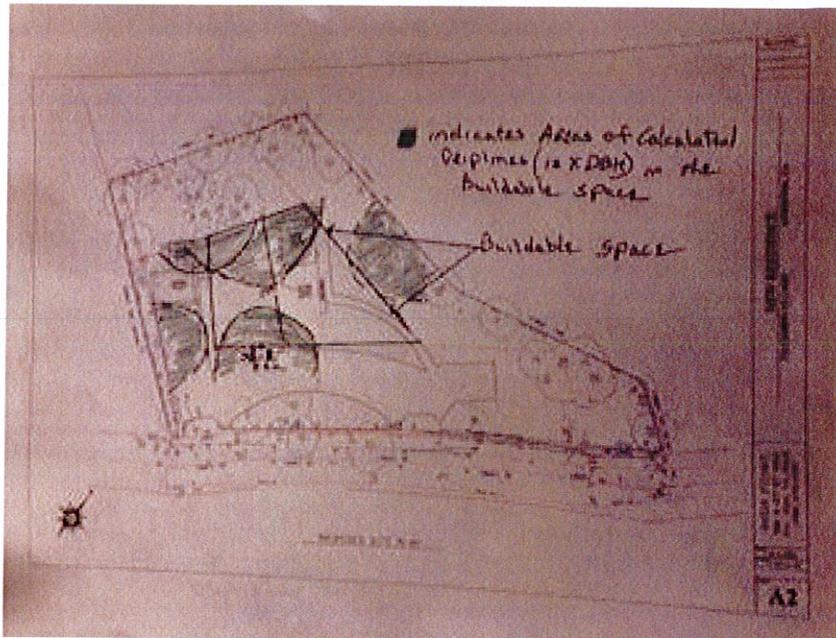
The oak tree in question is located on the southeast edge of the buildable space and has a dripline radius (12xDBH) of 38 feet. Two very large redwoods are located on the northwestern edge of the buildable space and their dripline radius is 52 feet. Trees on the side setbacks also encroach slightly into the buildable space.

**Map of buildable space encroached by the driplines of 5 of the 38 heritage trees on site. The odd shape of the buildable space makes the house design very difficult.**

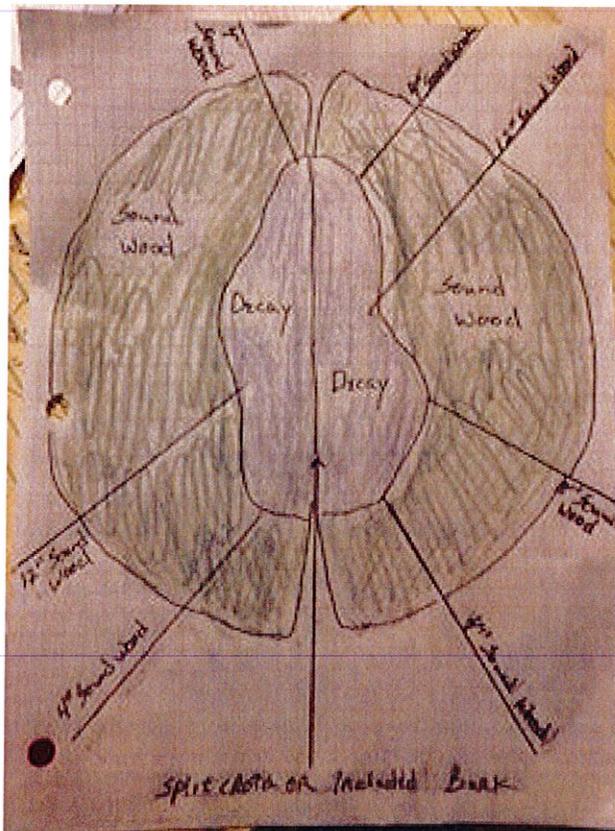
Several small 1/16 of an inch holes were drilled into the trunk to help detect decay and map decayed areas. The drill test also helps to identify included bark. The drill test detected pockets of decay below and beside the poor crotch formation. The pockets of decay were located 4", 8" and 12" inches inside the outer bark. The decay inside the trunk may increase the trees chances of failure at the poor crotch formation.

**A map of the drill test results shows area of decay surrounding the split crotch or included bark. The decay would increase the trees chances of failure.**

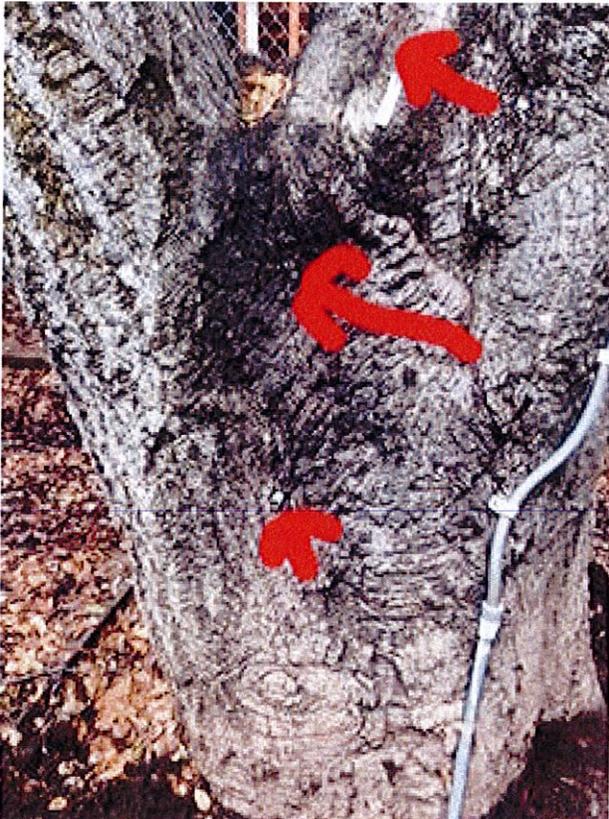
The large oak receives a condition rating of 45 on a 1-100 scale (poor). Attempts to improve the trees form have had limited results. The drain at the base of the crotch is an obvious indicator of decay in the trunk. The drill test confirmed the presence of decay. The cabling of the tree is the result of an arborist concerned about the possible failure of the large leader over the house. A second cable 30 or more years later confirmed the original arborist's doubts.

**Poor crotch formation with area of decay (top arrow), included bark (center arrow) and installed drain tube (lower arrow).**

Trimming the oak with ANSI standards and Best Management Practices will not improve the poor form of the tree or greatly lessen the trees chances of failure. The tree received a 10.5 out of a maximum of 12 making the tree a high risk tree. Any rating over 9 generally triggers mitigation or removal. Past mitigation has been less than effective in reducing the trees chances of failure and no new mitigation is recommended for this tree.

Remove and replace this oak as removal is the only method that will eliminate all hazard and liabilities associated with the tree. The oak should be replaced with a coast live or valley oak of a size acceptable to the town arborist or planning commission. One decayed heritage tree has been removed making this tree the second of forty heritage trees (5% of heritage trees) to be removed. Thirty eight heritage trees on a 1.17 acre lot makes this a high density well canopied lot.
