Item No. 11 Town of Atherton

CITY COUNCIL STAFF REPORT – REGULAR AGENDA

SUBJECT: REVIEW OF RECOMMENDATIONS REGARDING MEDIAN STREET TREES ON TUSCALOOSA AND MT. VERNON; PROVIDE FEEDBACK AND DIRECTION TO STAFF REGARDING THEIR DISPOSITION

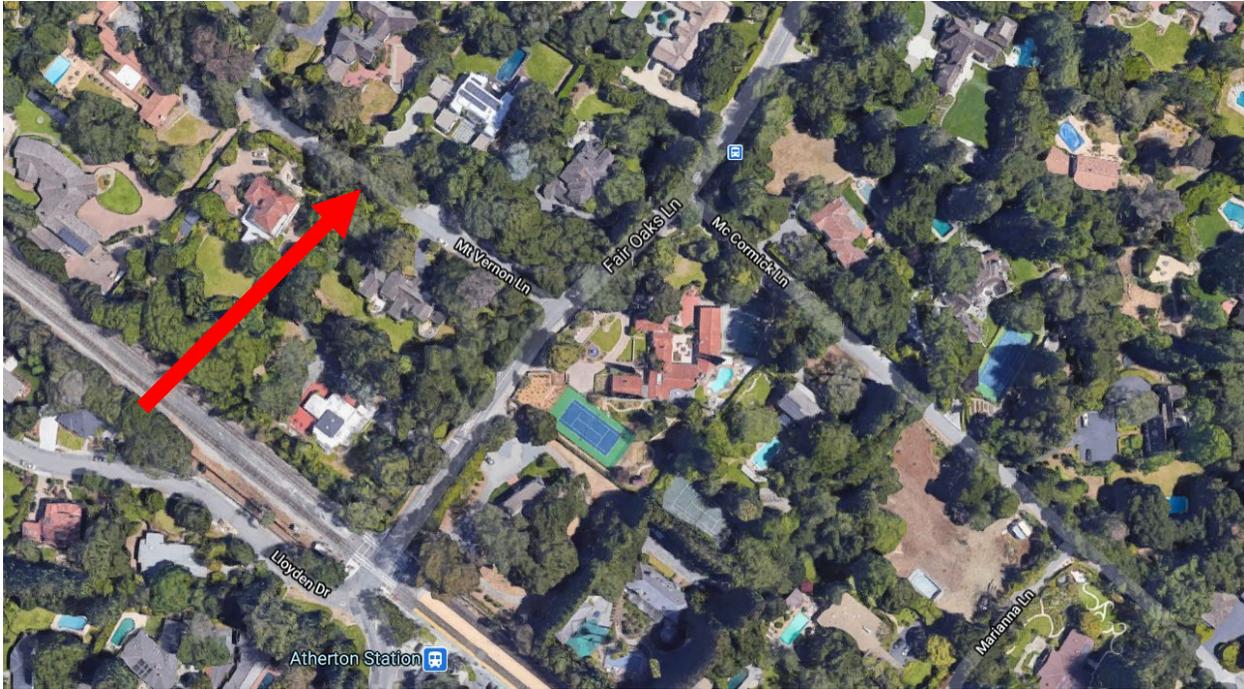
Figure 1: Red arrow indicates approximate location of subject tree.

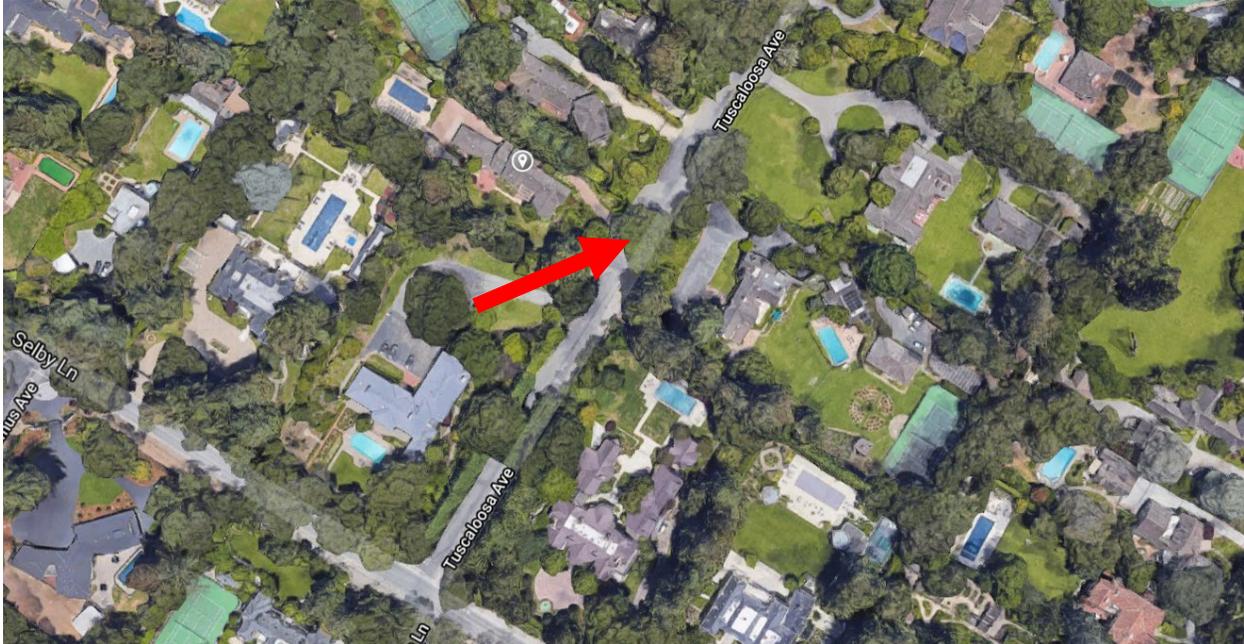
Figure 1: Red arrow indicates location of subject tree.

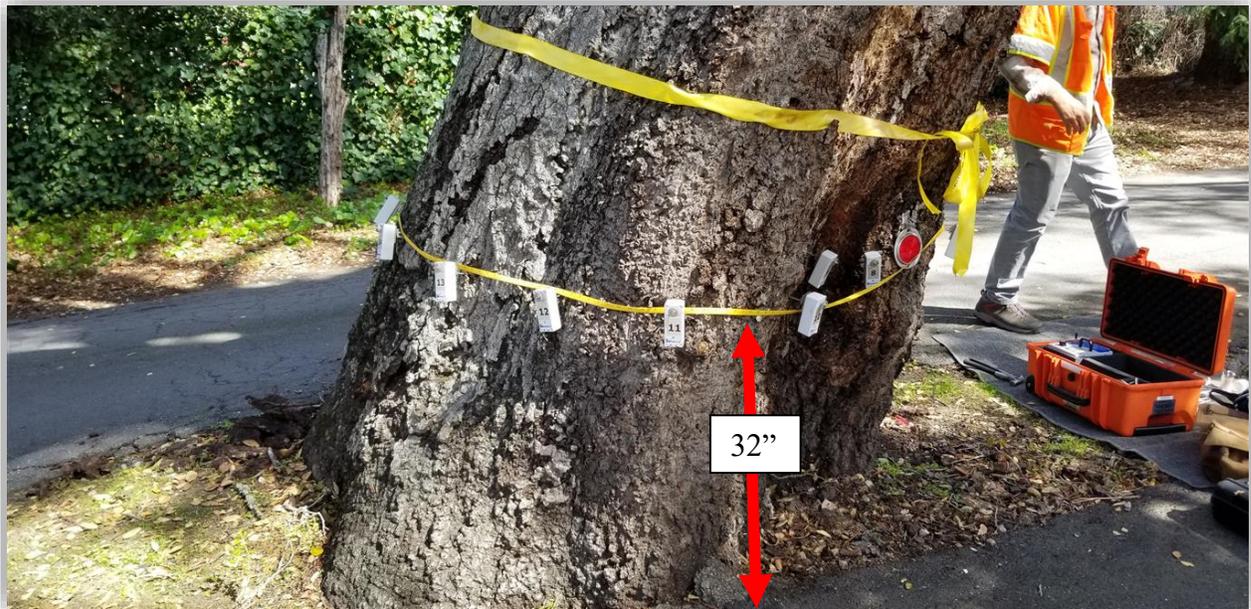
The tree's center of gravity looks to be to the south of the trunk based on **canopy** weight. I took a tomogram of the trunk at 32 inches up from the ground based on what I judged to be the weakest section in the trunk (see photo below). I also took one Resistograph® reading of the trunk, next to sensor #11. The readings are seen in the "Testing & Analysis" section below.

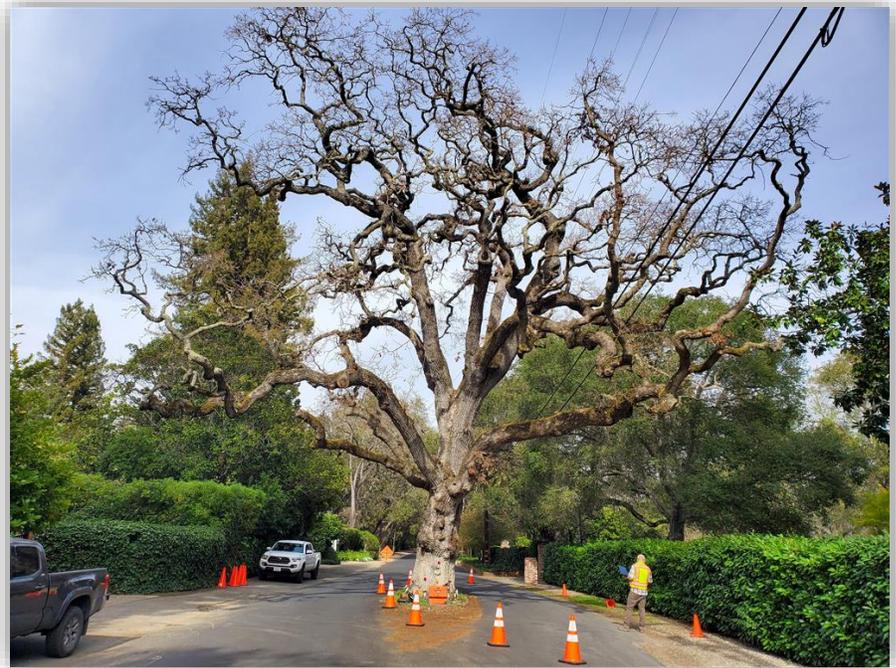
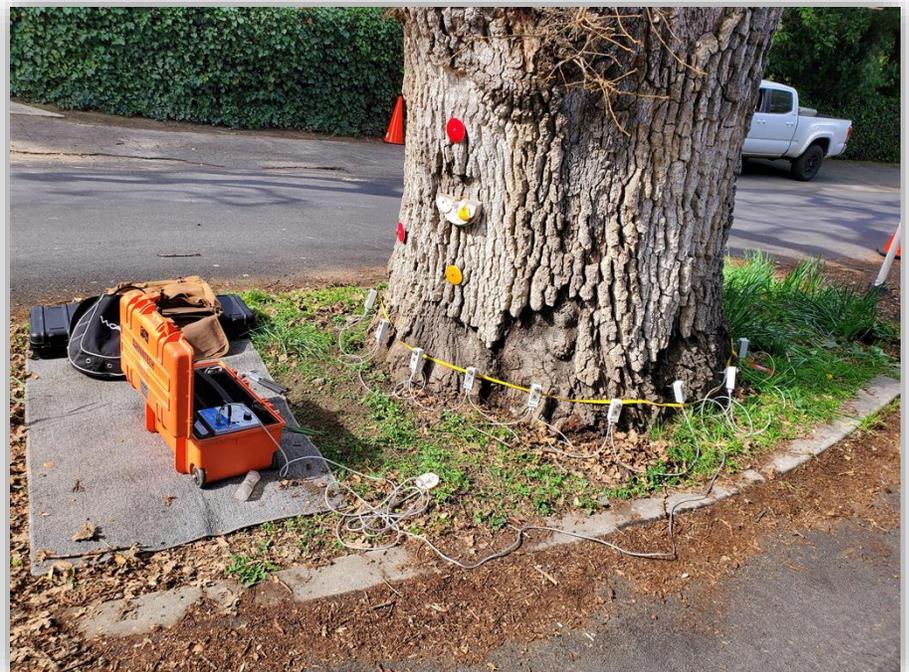
Valley Oak

At the time of inspection, this deciduous oak was without leaves (right photo). I observed a couple small, ground-level cavities on the west and south sides of the trunk (see Photo #3 in Appendix A).

I took a tomograph reading seven inches up from the ground. I also took two Resistograph® readings, behind sensors #4 and #11.

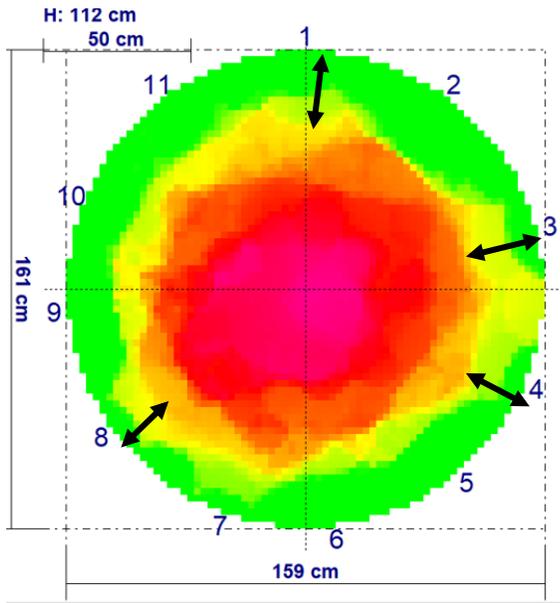
This tomogram shows a tree that has a large amount of mechanically dysfunctional wood in its center. However, the shell of the tree has about 9 inches of sound wood around the circumference (the black arrows in the image to the left roughly scale to 9 inches each).

To verify the findings of the tomogram, a Resistograph® was used to drill next to 4 sensors: #'s 1, 3, 4 & 8 – corresponding to the black arrows.

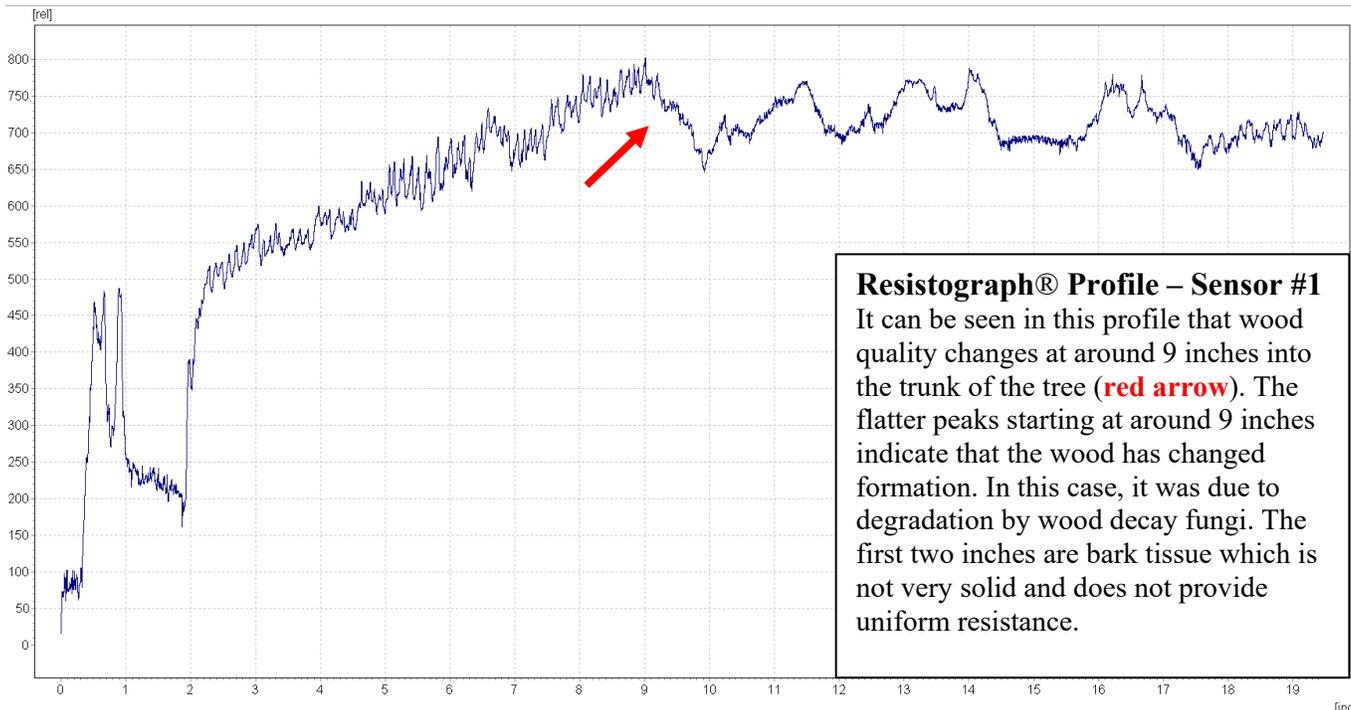
Resistograph® Profile – Sensor #1

The 4 Resistograph® (resistance drilling) profiles also indicate that there are around 9 inches of sound wood around the perimeter of the trunk. Below is the profile taken next to sensor #1. At about 9 inches into the trunk (**red arrow below**), the graph shows that the density/quality of the wood changes, verifying the change captured in the tomogram.

It can be seen in this profile that wood quality changes at around 9 inches into the trunk of the tree (**red arrow**). The flatter peaks starting at around 9 inches indicate that the wood has changed formation. In this case, it was due to degradation by wood decay fungi. The first two inches are bark tissue which is not very solid and does not provide uniform resistance.
