# **FEMA 356 Life Safety Building Performance Evaluation & PML Analysis**

**Atherton Library  
2 Dinkelspiel Station Ln.  
Atherton, California**

September 24, 2009

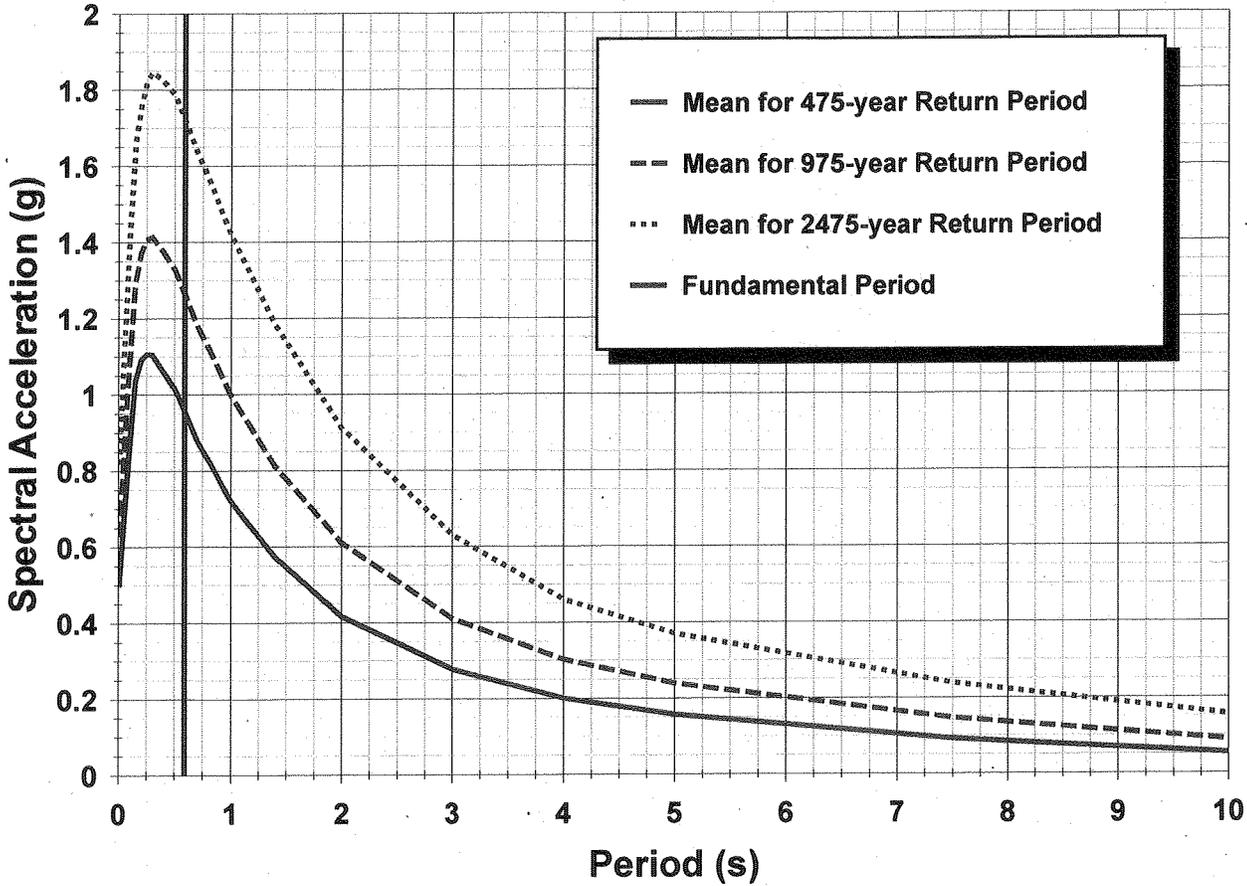
### Uniform Hazard Spectra

## SPECTRAL RESPONSE SUMMARY

**Spectral Response Values**

Period (s)	10% in 50 yrs (g)	5% in 50 yrs (g)	2% in 50 yrs (g)
(0.59)	0.95	1.26	1.71
PGA	0.50	0.63	0.82
0.1	0.86	1.08	1.41
0.15	1.04	1.29	1.66
0.2	1.09	1.37	1.76
0.25	1.11	1.41	1.82
0.3	1.10	1.41	1.85
0.4	1.06	1.37	1.82
0.5	1.02	1.33	1.79
0.7	0.88	1.18	1.64
1.	0.72	1.00	1.42
1.4	0.57	0.81	1.18
2.	0.42	0.61	0.91
3.	0.28	0.41	0.63
4.	Report generated by ST-RISK Version 4.41		0.46
5.	0.16	0.24	0.37
7.5	0.09	0.15	0.24
