## Item No. 19 Town of Atherton

### **ATHERTON CHANNEL DISTRICT – REGULAR AGENDA**

**SUBJECT: DISCUSSION OF DRAINAGE MASTER PLAN PROJECTS  
SPECIFIC TO THE ATHERTON CHANNEL DISTRICT AND  
DISCUSSION/DIRECTION ON NEXT STEPS FOR SPECIAL  
DISTRICT FUNDING**

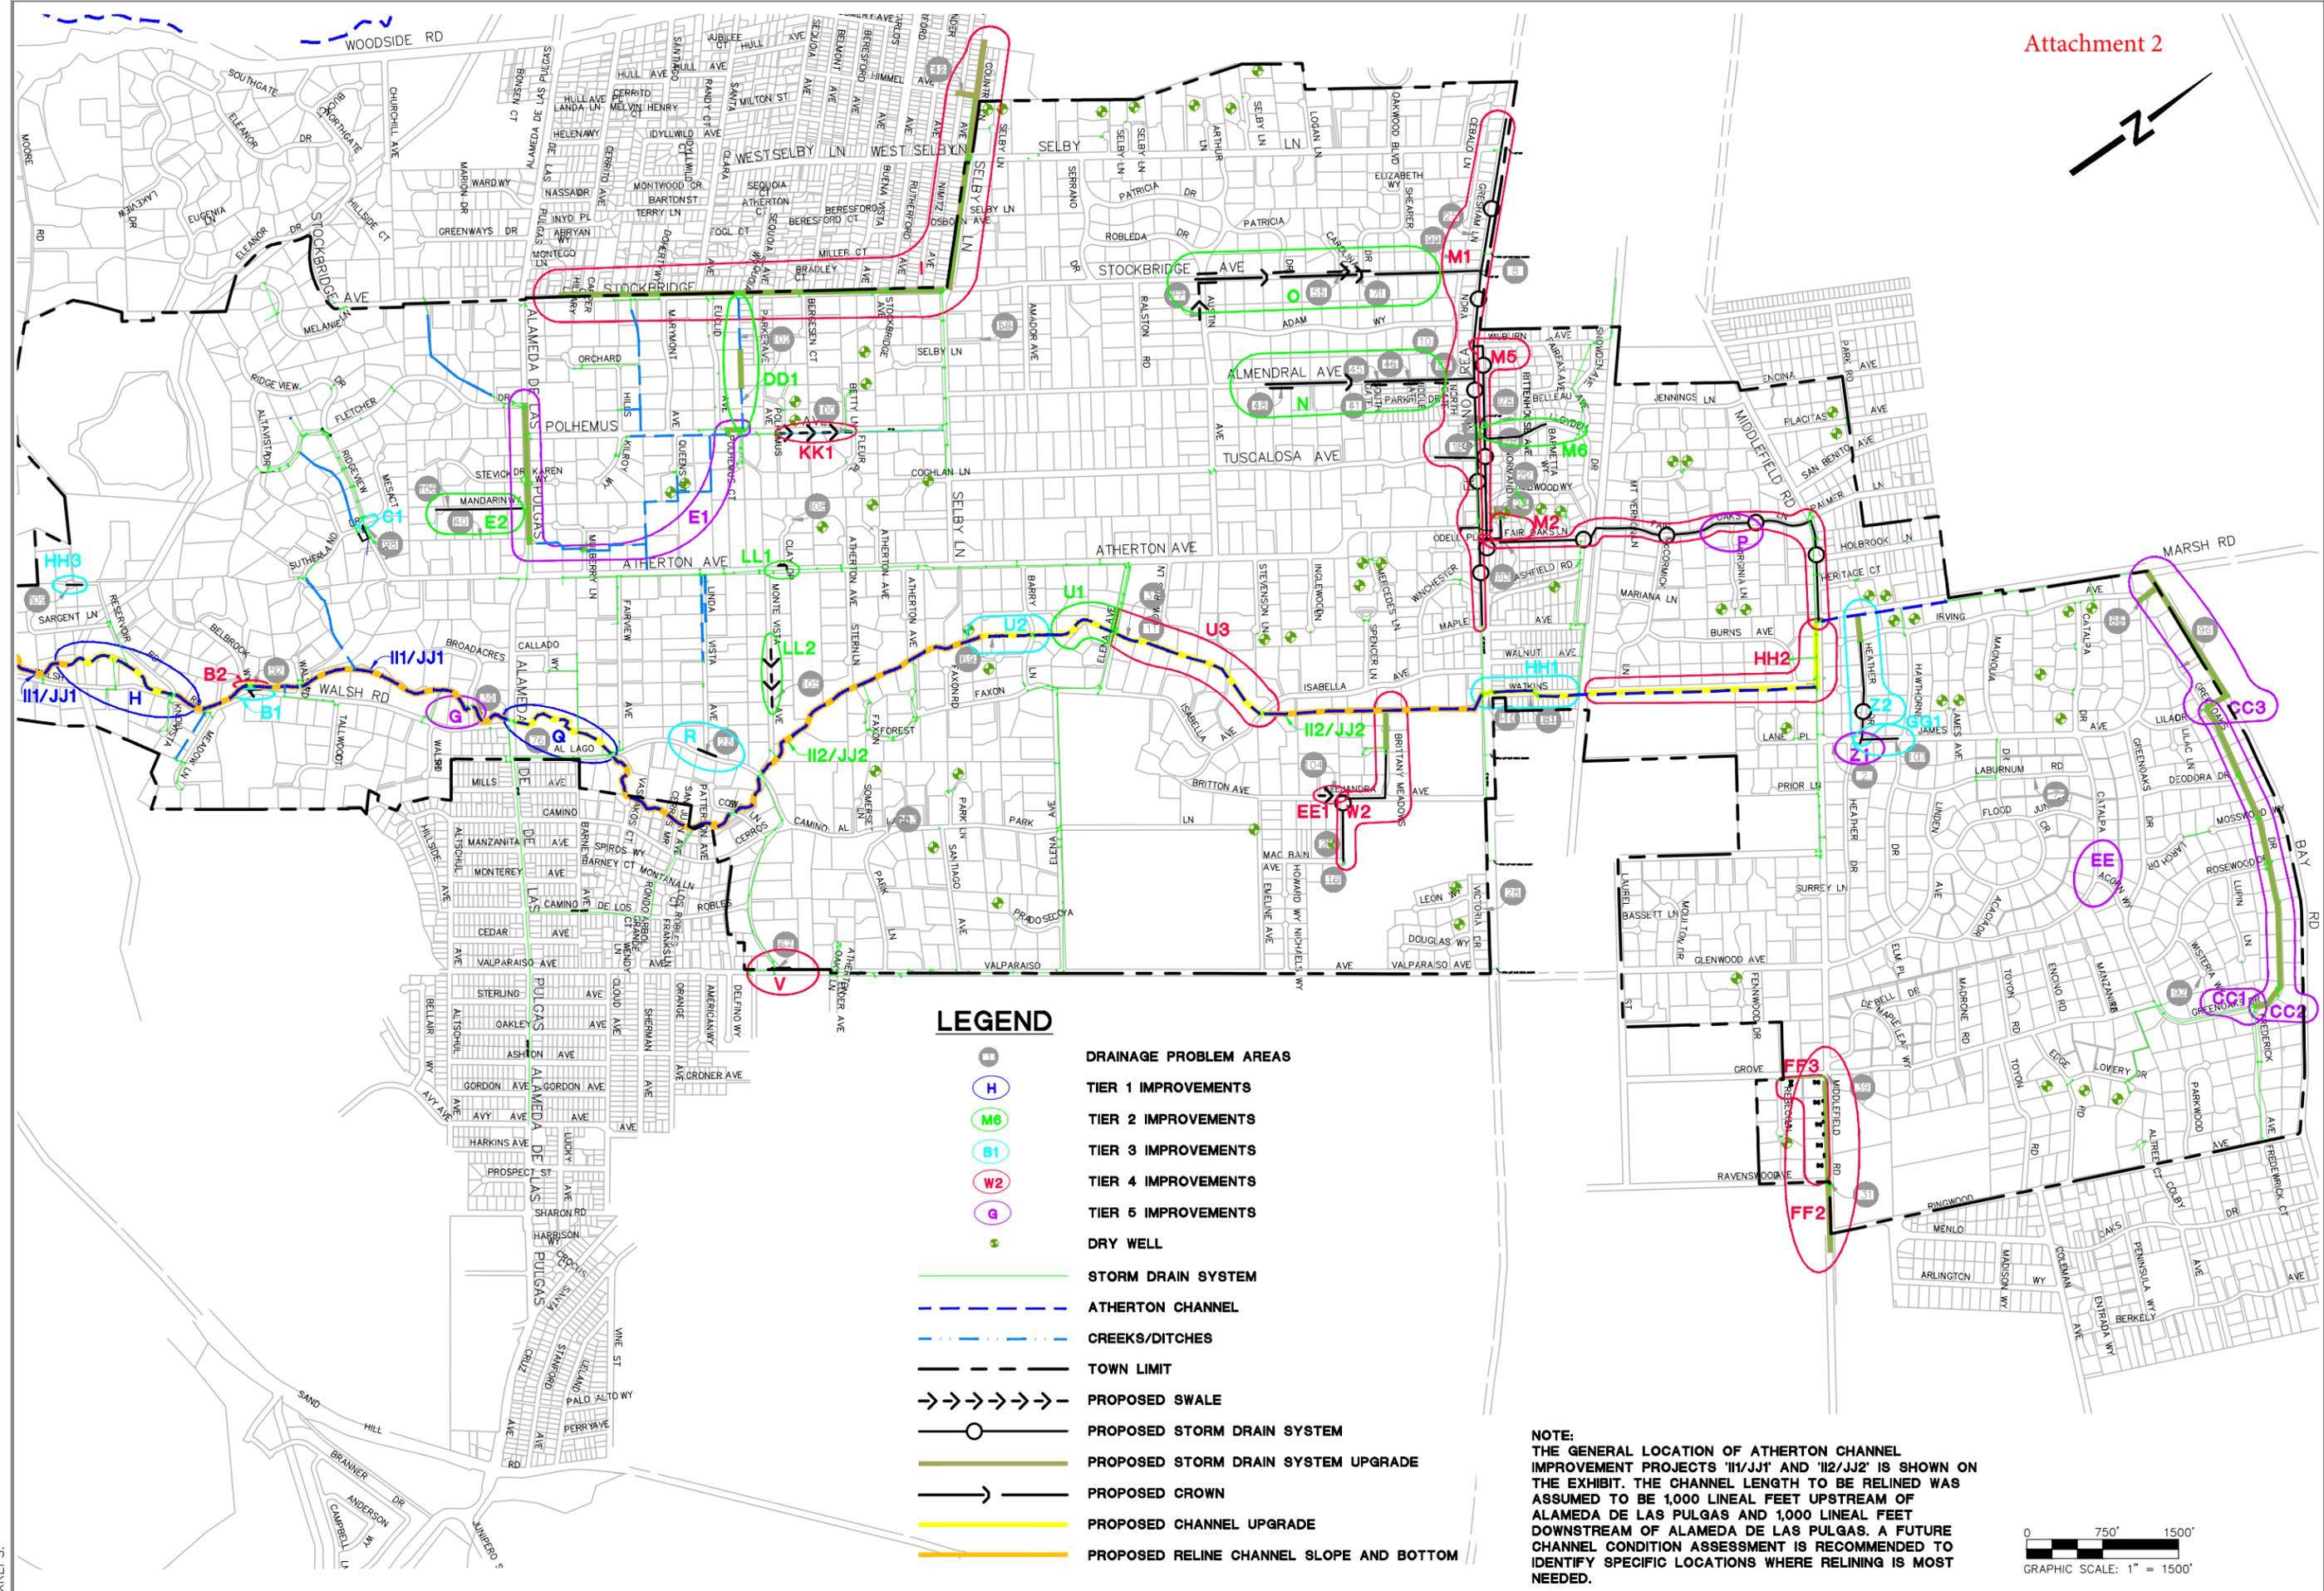
LEGEND	
	DRAINAGE PROBLEM AREAS
	TIER 1 IMPROVEMENTS
	TIER 2 IMPROVEMENTS
	TIER 3 IMPROVEMENTS
	TIER 4 IMPROVEMENTS
	TIER 5 IMPROVEMENTS
	DRY WELL
	STORM DRAIN SYSTEM
	ATHERTON CHANNEL
	CREEKS/DITCHES
	TOWN LIMIT
	PROPOSED SWALE
	PROPOSED STORM DRAIN SYSTEM
	PROPOSED STORM DRAIN SYSTEM UPGRADE
	PROPOSED CROWN
	PROPOSED CHANNEL UPGRADE
	PROPOSED RELINE CHANNEL SLOPE AND BOTTOM

**NOTE:**  
 THE GENERAL LOCATION OF ATHERTON CHANNEL IMPROVEMENT PROJECTS '111/JJ1' AND '112/JJ2' IS SHOWN ON THE EXHIBIT. THE CHANNEL LENGTH TO BE RELINED WAS ASSUMED TO BE 1,000 LINEAL FEET UPSTREAM OF ALAMEDA DE LAS PULGAS AND 1,000 LINEAL FEET DOWNSTREAM OF ALAMEDA DE LAS PULGAS. A FUTURE CHANNEL CONDITION ASSESSMENT IS RECOMMENDED TO IDENTIFY SPECIFIC LOCATIONS WHERE RELINING IS MOST NEEDED.

1. Town Wide Drainage Study Update Table 6-1: Summary of Recommended Drainage Improvement Projects
2. Town Wide Drainage Study Update Figure 6-1: 2014 Prioritized Improvement Projects
3. Town Wide Drainage Study Update Table 6-2: Background for Recommended Projects

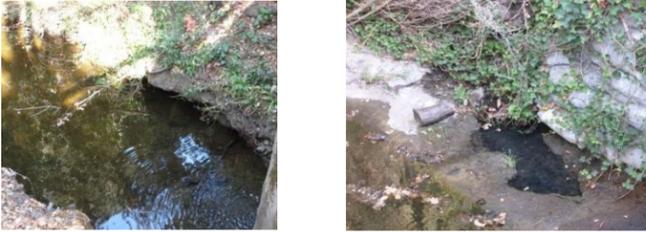
AREA	LOCATION	PROBLEMS	SOLUTIONS
JJ1 – Reline Channel Bottom, Phase 1	Atherton Channel	<ul style="list-style-type: none"> <li>The channel bottom lining has cracks and holes, see 2013 photos.</li> <li>Life expectancy of the channel has been exceeded.</li> </ul>

<ul style="list-style-type: none"> <li>Regrade the bottom of the channel. Assume total channel length of 1000 lineal feet is in need of repair.</li> <li>Channel to be repaired excludes sections where other channel improvement projects are identified.</li> <li>This project would be phase 1 of two projects. Phase 1 would restore areas most needing improvement upstream of Alameda de las Pulgas.</li> <li>To identify specific locations most needing improvements, a condition assessment of the existing channel is recommended prior to design of channel improvements.</li> </ul>
<b>Tier 2</b>			
II2 – Reline Channel Slopes, Phase 2	Atherton Channel	<ul style="list-style-type: none"> <li>The channel side lining has minor cracks and holes</li> </ul>	<ul style="list-style-type: none"> <li>Restore the sides of the channel. Assume total channel length of 1000 lineal feet is in need of repair.</li> <li>Channel to be repaired excludes sections where other channel improvement projects are identified.</li> <li>Expand the life expectancy of the channel.</li> <li>This project would be phase 2 of two projects and would address areas from Alameda de las Pulgas to El Camino Real.</li> <li>To identify specific locations most needing improvements, a condition assessment of the existing channel is recommended prior to design of channel improvements.</li> </ul>

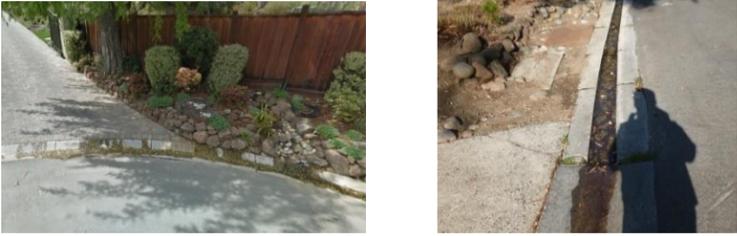
GG1 – James and Hawthorne Storm Drain System	Intersection of James Avenue and Hawthorne Drive and upstream tributary flow paths that contribute flows to this area.	<ul style="list-style-type: none"> <li>• Intersection floods very quickly.</li> <li>• The intersection is a sag area along James Avenue and flows coming from adjacent areas from Middlefield Road and Hawthorne Drive converge at this intersection.</li> </ul>	<ul style="list-style-type: none"> <li>• Create a release point by installing a storm drainage system from the low point of the intersection connecting to the proposed system along Heather Drive and into the existing storm drainage discharge pipe into Atherton Channel.</li> </ul>
HH3 – Reservoir Road Regrade and Crown	Reservoir Road cul-de-sac	<ul style="list-style-type: none"> <li>• Standing water and debris along swale in front of property.</li> </ul>

<ul style="list-style-type: none"> <li>• Install storm drain system with inlets upstream and downstream of property (bubbler system) or extend rock trench drain swale further upstream.</li> </ul>
